# Tech Tip

## **Product Effected –CAT Engines w/2007 Emissions**

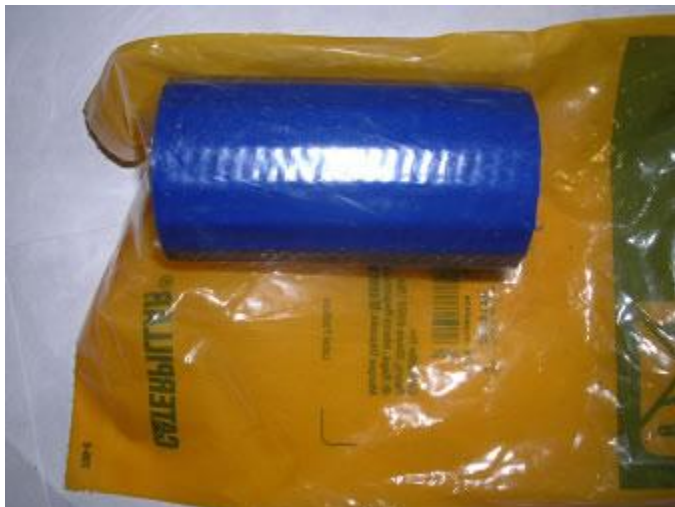
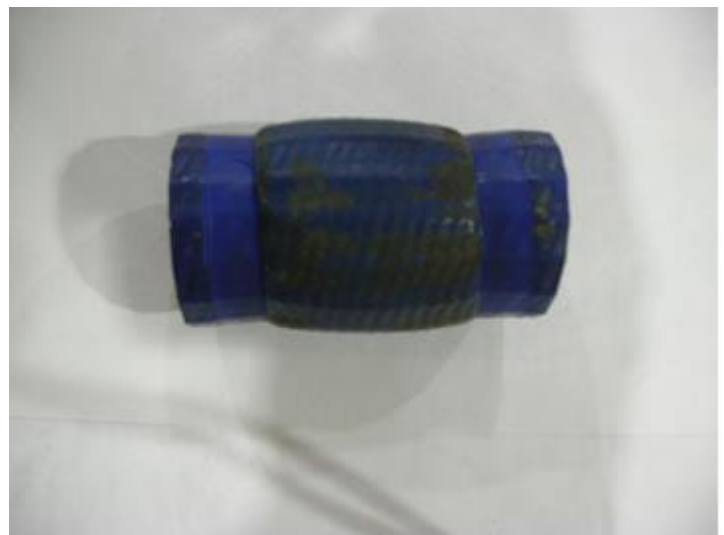
**PLEASE NOTE:** *These hoses should be checked periodically during normal PM inspections. You should release the pressure from the cooling system by loosening the radiator cap before you raise the unit for inspection. Let the unit cool down during inspection and once cool locate the “blue” silicone hoses (Figure #1) on the right side of the motor as shown as item #5 in Figure #5. You should first look at the hoses as they will first appear to Bulge as in Figure #2. Should the hose appear to bulge and if the engine has cooled enough you can squeeze the hose and feel if it has begun to deteriorate. As you can see in Figures #3 and #4*

**Correction:** *Replace the blown hose(s)*
