From your friends at New York Bus Sales

Product Effected - Blue Bird units with Air Brakes

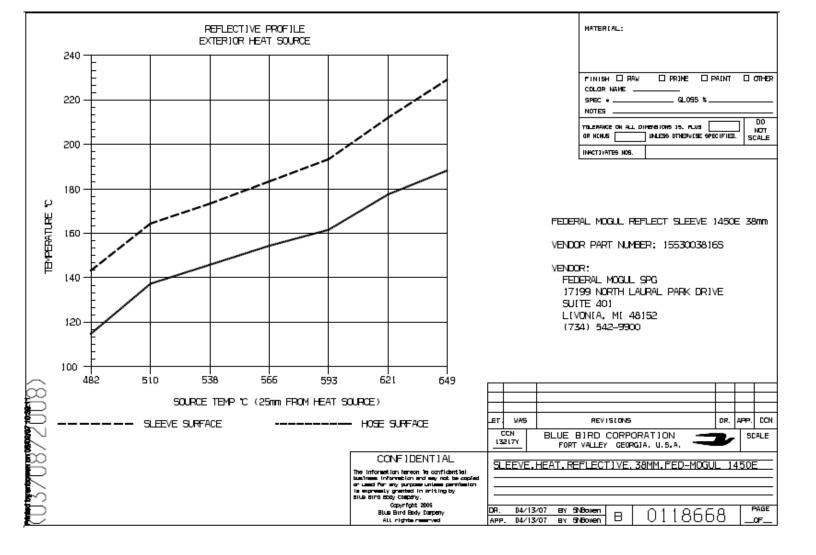
The steel guard used to insulate the rear air lines from exhaust heat Complaint:

cause the exhaust pipes to prematurely rust thru.

Cause: These shields being down where all the road debris, slush, ice and

> those wonderful chemicals used on the road have cavities and voids where these items are held and cause the process of deterioration

to accelerate.

Correction: Blue Bird currently uses a sleeved "heat shield" which goes over

the air hoses to protect them from heat. These sleeves can be used

in lieu of the steel heat shield.

PLEASE NOTE - HEAT SLEEVE PART # 00118668
