Tech Tip

Blue Bird Body Cracks-“A” Pillar and Bow Covers

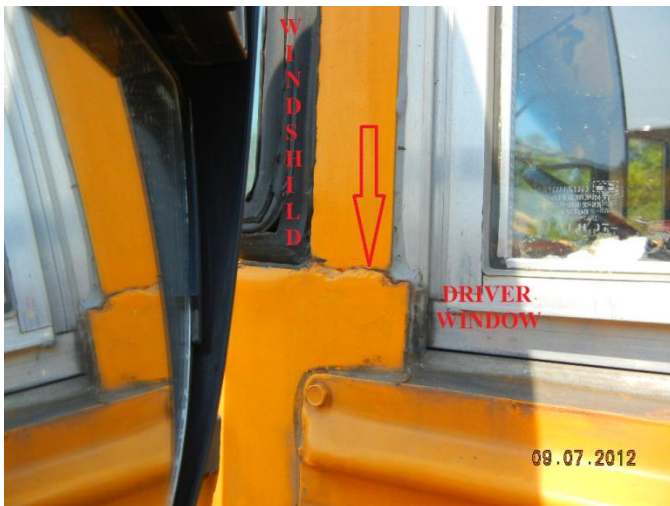
Complaint – “A” pillar is cracking at the bottom where it is welded (by the front lower corner of the driver window) Please see Figure #1

Cause – Flexing of the body causes these “trim” pieces to crack. Blue Bird has confirmed that these are just “trim” and have nothing to do with the structure of the vehicle.

Correction – As shown in both Figure #1A and #2A, grind the cracks to form a “V”. After doing so, use **Yellow Manus-Bond**

part #10027537 in the “V” crack as shown in Figure #1B and #2B – Paint if necessary.

PLEASE NOTE-SHOULD THE CRACKS OPEN BACK UP WIDER THAN THE ORIGINAL "V" THEN THE INTERIOR OF THE "A" PILLAR NEEDS TO BE REMOVED AND THE PILLAR INSPECTED TO MAKE SURE THERE IS NO CRACKING. THE SAME THING IS TRUE OF THE BOW POST COVER BUT THE COVERS WILL NEED TO BE REMOVED FOR INSPECTION

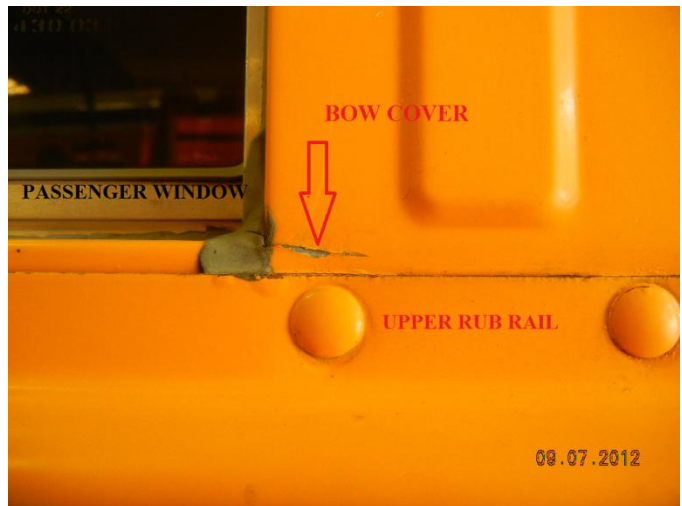
The “Bow” covers between the passenger windows are cracking at the bottom along the upper rub rail. Please see Figure #2
