Tech Tip

BBCV-Vision/CAT C7 Heat Loss & Added Coolant Pressure

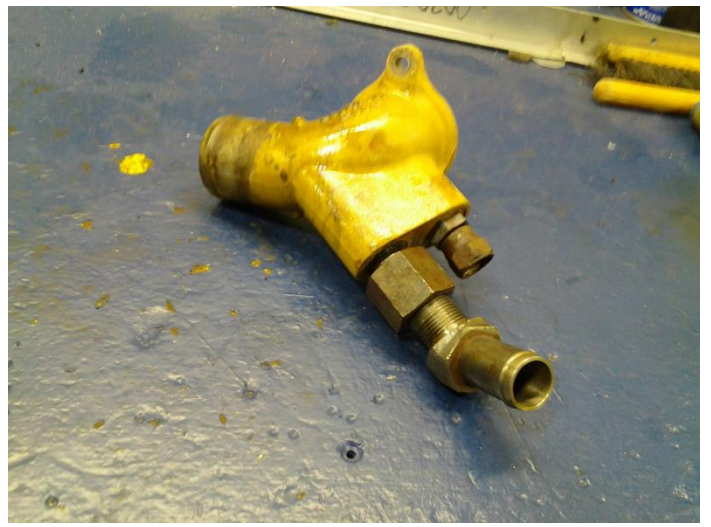
Photo #2

- #3 – Remove the hoses from the housing and remove the housing from the engine – Photo #2.....be mindful when removing as to not tip or turn the housing upside down, or if you have to watch for the small plastic nubs falling out.

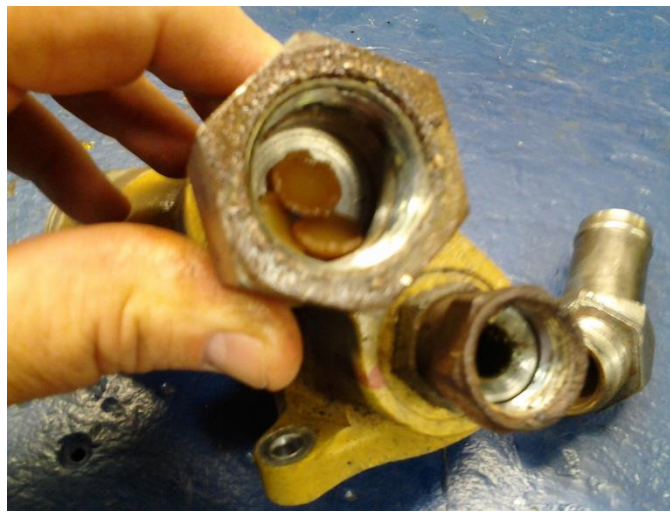
- #4 – Once off, inspect and look for the nubs which if are the issue will be in the port shown in Photo #3
 - #5 – Remove nubs, clean housing and fitting, reseal, replace gasket and reassemble.

- #6 – Replace surge tank, fill coolant system, bleed system and pressure test.
 - #7 – Run unit to operating temperature and make sure there is now heat
