Tech Tip

BBCV Front ABS Sensor Wiring on Air Brake Units

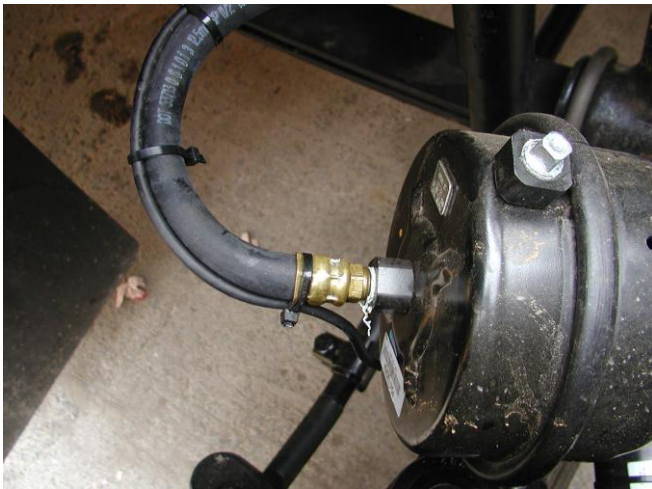
- Complaint –** The ABS light is on and we have checked the sensors and tone rings and everything seems to be good-
- Cause –** The sensor wire has become “chaffed” through at fitting near the brake chamber. As you can see in Figure #1 it appears that the sensor wire is nicely tied up, which it is. Upon further inspection as you can see in Figure #2, the crimped fitting has worn into the sensor wire as shown in Figure #3 causing it to ground against the metal thus throwing the ABS light!
- Correction –** Removing the ties and installing wire loom over the sensor wire and then putting the wire tie closet to the end of the hose back on the rubber part of the hose about ½” as in Figure #4 will not allow the metal to chaff into the wire. As added protection you could also wrap electrical tape around the hose where the metal end is crimped on.
