Tech Tip

Type C & D Exhaust Rusting

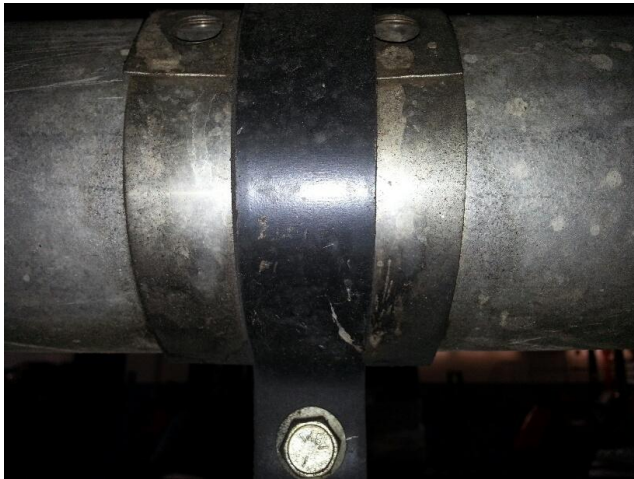
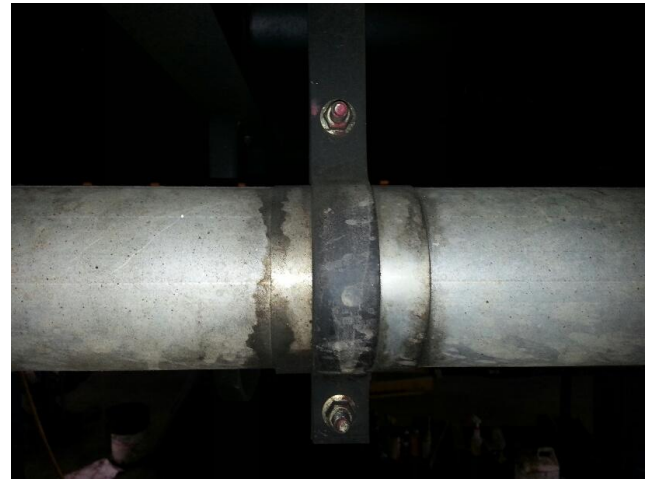
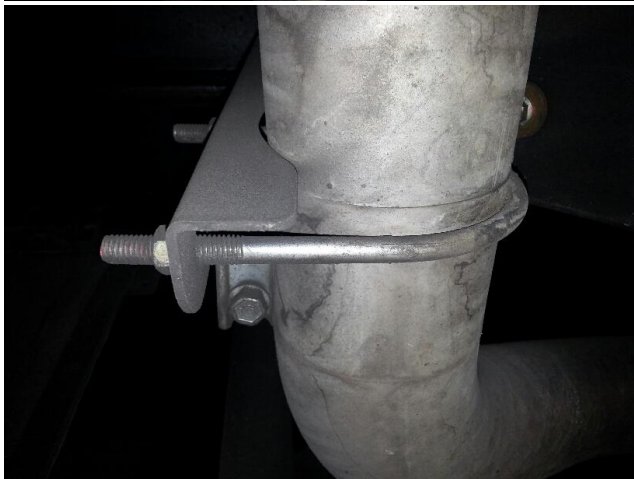
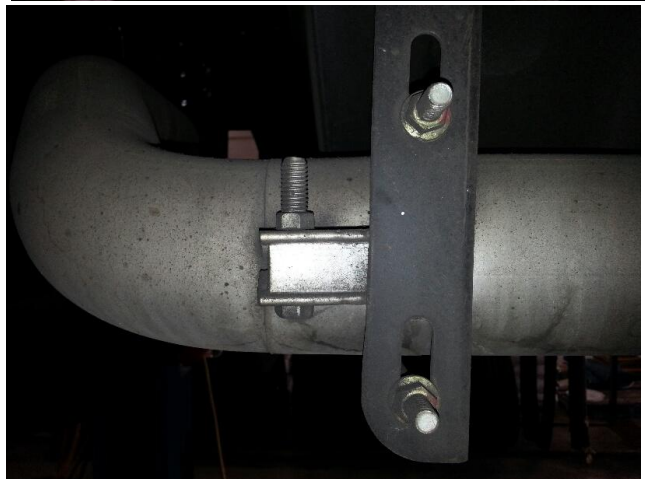
- Complaint –** Exhaust seems to prematurely rust
- Cause –** We believe due in part to some of the higher exhaust temperatures we are seeing on diesel engines today along with the salt and chemicals laid on the roads during the winter months that the exhaust pipes are suffering! What we have seen in the field is that the aluminized pipe seems to hold up fairly well EXCEPT where steel clamps fasten it, and in those areas it seems almost like a dissimilar metal reaction occurs which cause the pipes to rust.
- Correction –** One operator has taken to using the stainless steel band clamps as an insulator against this – As shown in the photos below

New York Bus Sales has also taken the step of adding Stainless Steel u-bolt saddle clamps to their inventory as an alternative to purchasing the standard steel to help deter the process on your units!
