Tech Tip

FROM YOUR FRIENDS AT
NEW YORK BUS SALES!

2013-2014 BBCV/Cummins Front Exhaust Hitting Shackle Bolt

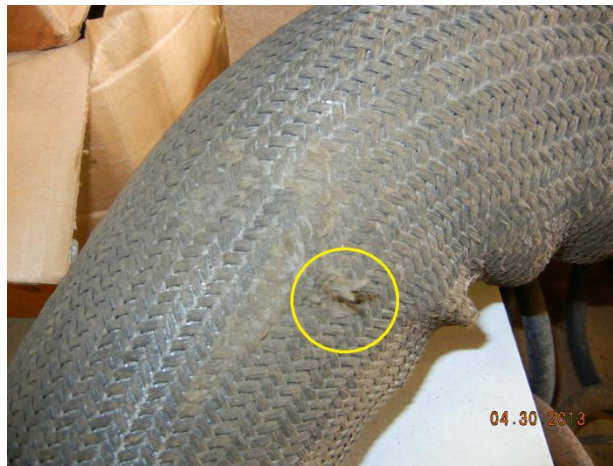
Photo #1

Complaint – There is a tear (Photo #1) in the protective sheathing that is wrapped around the “Turbo Pipe” (Pipe that runs from the engine to the DPF).

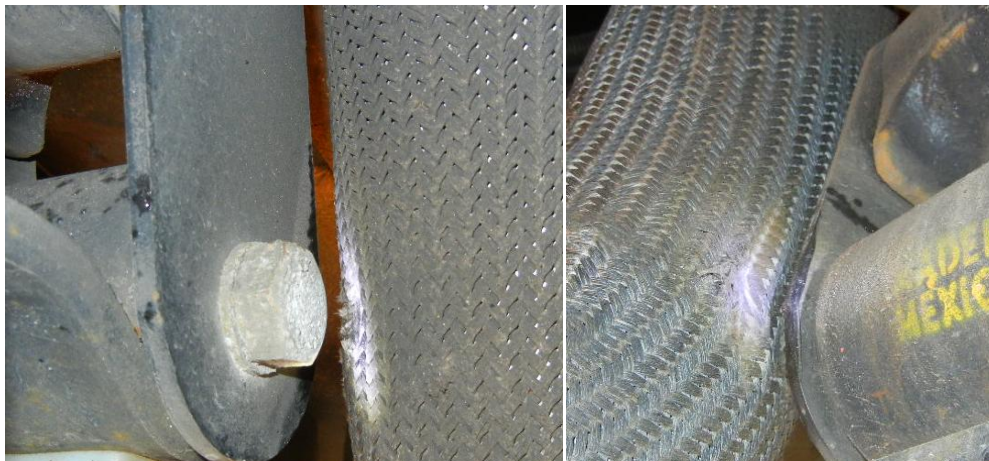
Photo #2

Cause – The pipe is too close to the shackle side bar and bolt head (Photos #2 & #3) on the right lower mount and as the suspension works it contacts the exhaust pipe. Failure to address causes the sheathing to become worn and eventually rip. This covering/insulation is required for emissions and should it become compromised the pipe will need to be replaced as there is not currently a repair procedure.

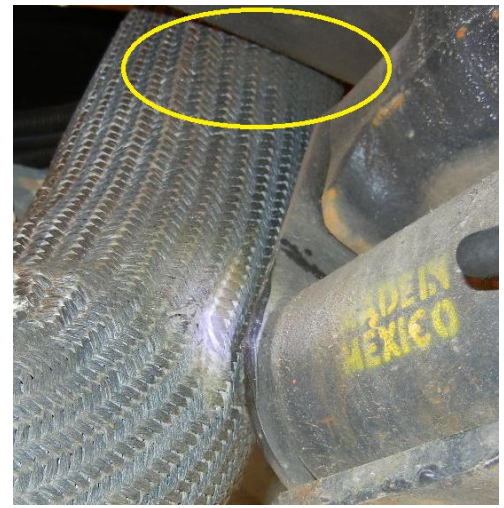
Photo #4

You can also see by the photo to the right (#4) that the exhaust rests right against the lower frame rail flange.

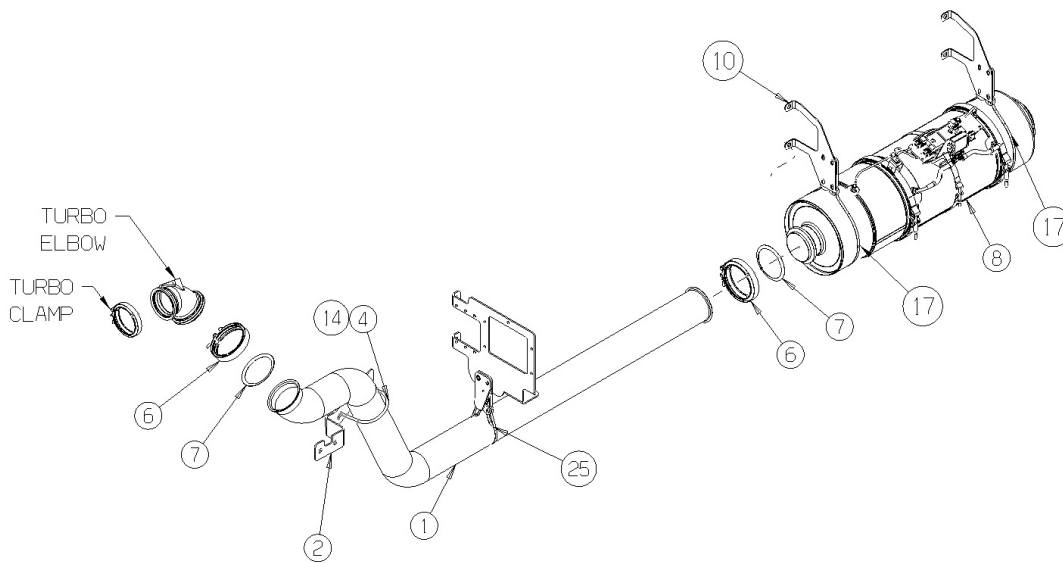
Correction – Looking at Diagram #1 you will notice that the first spot that the exhaust is mounted to the chassis is where bracket #2 and U-bolt clamp #4 are located.

You should first loosen the turbo clamp and clamp #6 in Diagram #1 so that the pipe will rotate easily. Once the clamps are loose, you can remove the clamp (#4) and if you obtain a 4" HD exhaust clamp with a saddle install as shown in Photo #6. This will move the pipe over away from the frame flange and allow room for the suspension to work (Photo #7). Once you have the clamp saddle in place and the pipe aligned where it should be, torque clamp #6 to 8-10 ft/lbs and the turbo clamp to 124 in/lbs.

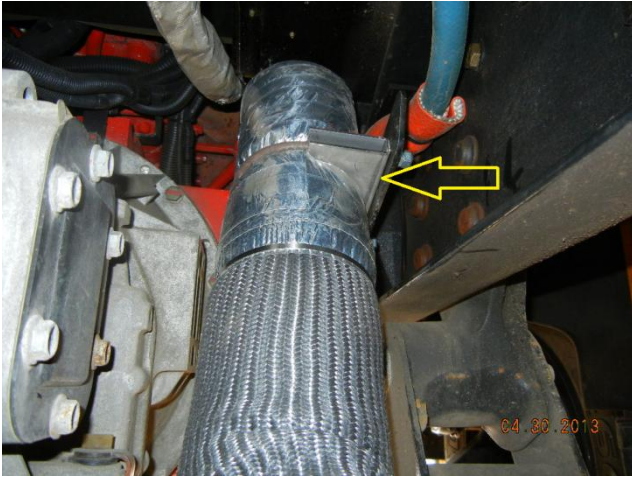
Photo #6

Looking at photo #6 at the left you will notice how the bracket and clamp appear as mounted to the unit. You will notice that the clamp contains just the threaded rod portion and there is no saddle.

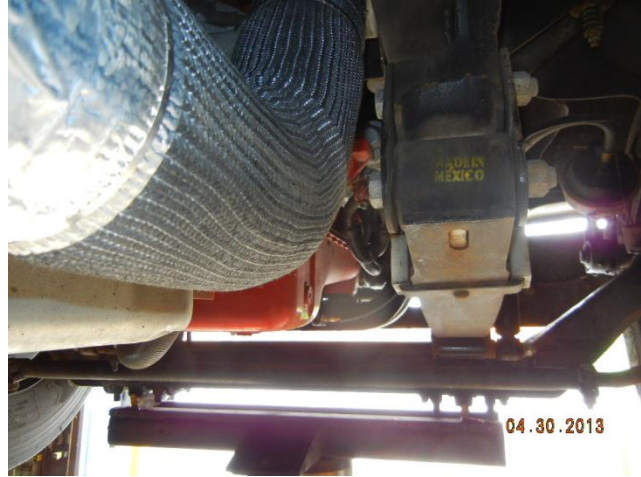
Photo #7

H.D. Exhaust Clamp Part #00065
List \$2.74
