Tech Tip

FROM YOUR FRIENDS AT
NEW YORK BUS SALES!

D3FE (All American) Radiator Cap Relocation

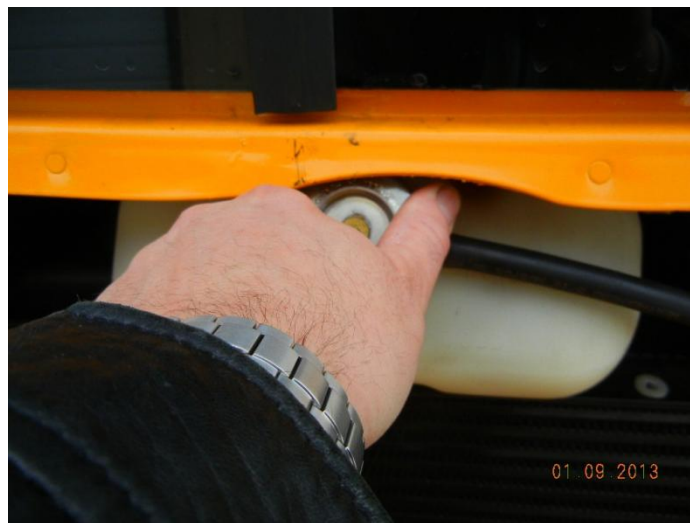
Complaint – The radiator cap is not in a position to be easily removed by drivers or techs who need to check the coolant level.....In many cases there is only room for their thumb and index finger to remove the cap. See Photo #1

Cause – The filler neck is too short and does not bring the cap out far enough to get a good grip on it for some drivers/techs.

Correction – New York Bus Sales has found a supplier that has designed and is making a filler neck which is longer and comes out past the windshield frame allowing drivers/techs to be able to grasp and remove the cap with their whole hand instead of their index finger and thumb.

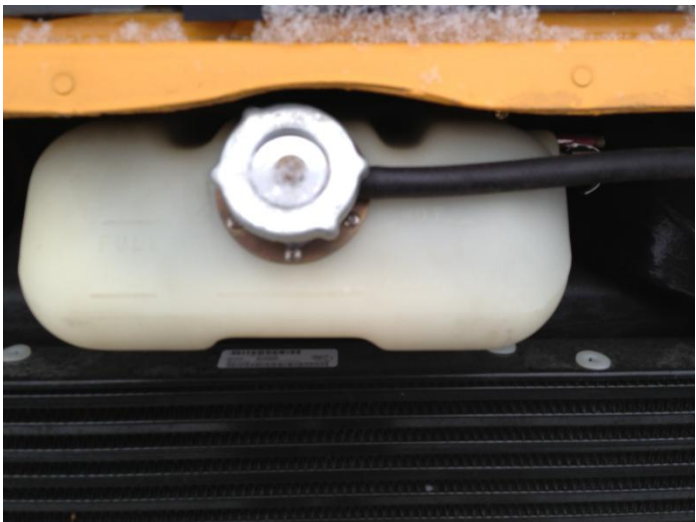
Photo #2

- #1 – Open the engine hood to reveal coolant tank (Photo #2 & #3) – This will work with earlier style hoods which lift out and up as well and the newer style which open out and down

- #2 – As you can see by the first 2 photos, on some units the radiator cap is actually partially covered by the lower windshield frame – The filler neck is smaller in diameter than the radiator cap and will fit even when it seems to close but in some instances you may need to reposition the coolant tank slightly to gain clearance.

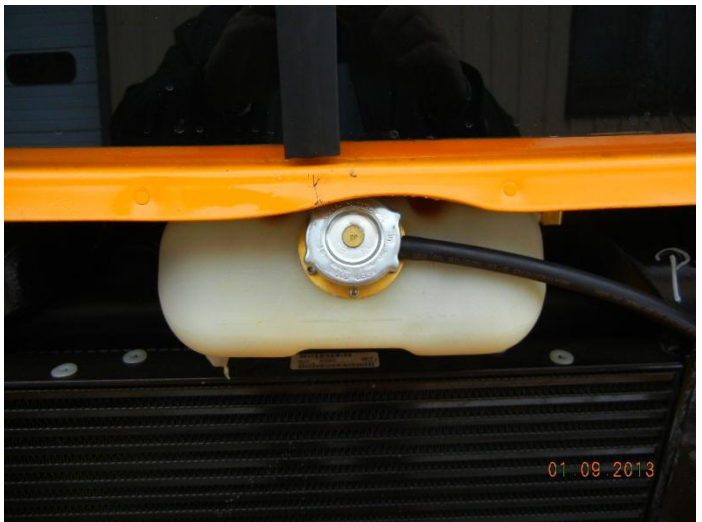
Photo #3

- #3 – Remove the overflow hose from the neck (Photo #4).
- #4 – Next use either a 3/32”(earlier models) or a 9/64” hex wrench (Photo#6) to remove the 6 screws holding the neck to the tank (Photos #3 & #4)

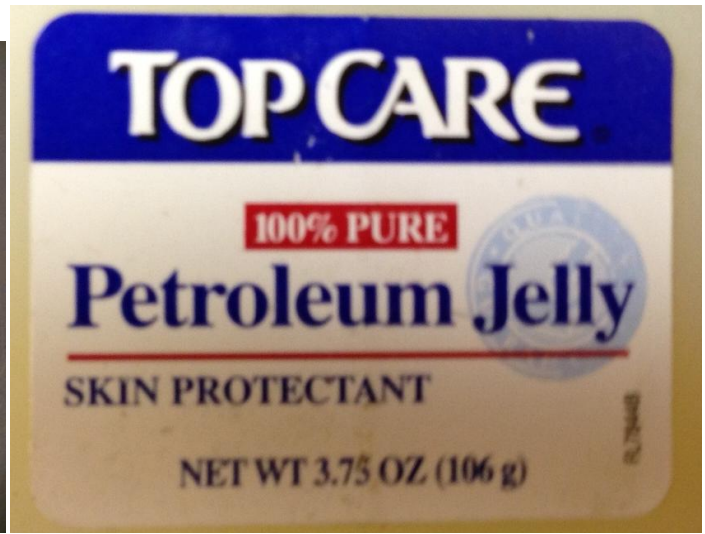
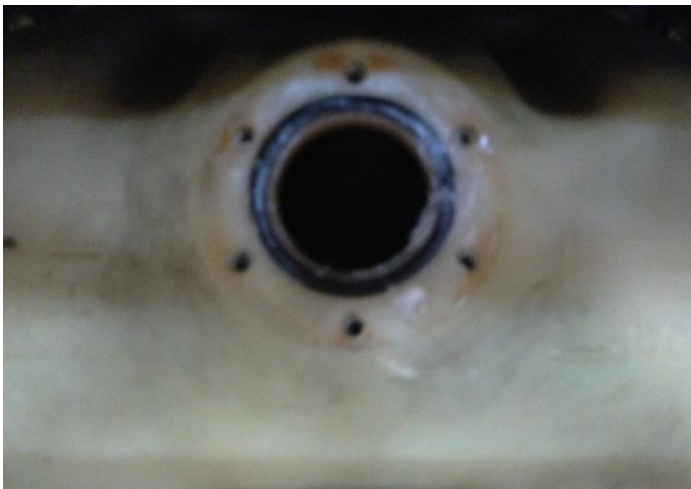
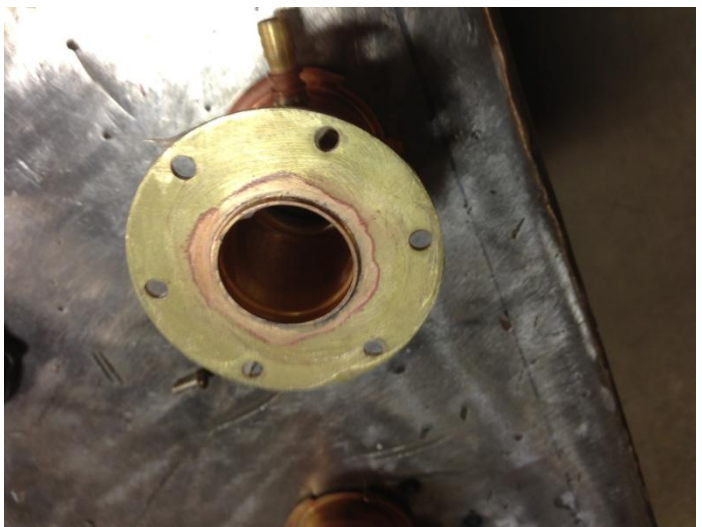
- #5 – Once the original neck has been removed, check the “O” ring seal for any signs of damage and replace if necessary. We use common petroleum jelly and apply a light coating to both the neck base and the tank and “O” ring (Photos #7-#9).

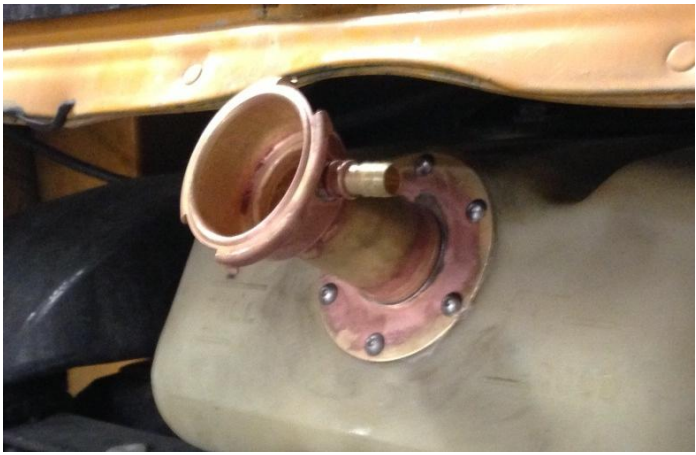
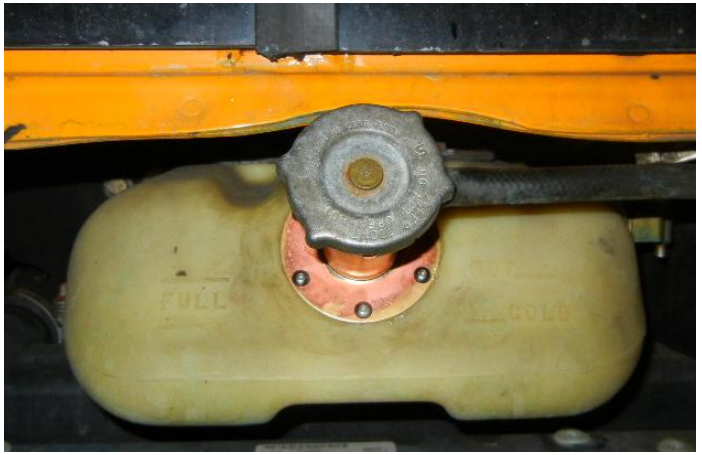
- #6 – Using the screws which held the original neck, reinstall the new neck positioning the overflow hose barb in the same position as the original neck. Tighten the screws evenly in a star type manner and reinstall the overflow hose and radiator cap (Photos #10 & #11)

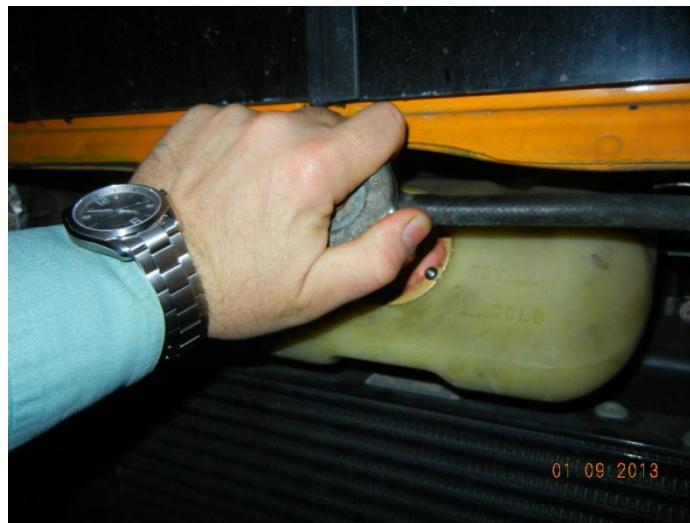
Photo #12

- #8 – Release the vehicle back into service where drivers/techs can now get a good grip on the radiator cap to remove it (Photo #12)
