Window Latches

Complaint -

- > Some windows are falling down past the stops
- ➤ The latches are loose in the upper channel and slide to the center

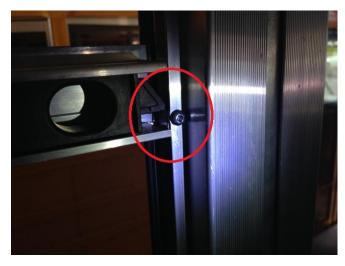
The window "stops" which are designed to allow the windows to only open so far to meet DOT regulations are not straight in the channel and the upper portion where the latch catches on is inward – See Figure #1

Straighten the window stops in the channel (See Figure #6) and to assure the latches seat properly, replace them.

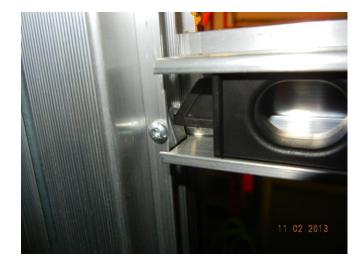
When this occurs the tip of the latch can pass by the stop and allow first the one side to drop pass the stop and then the other when the latch is pulled inward – See Figure #2 & #3

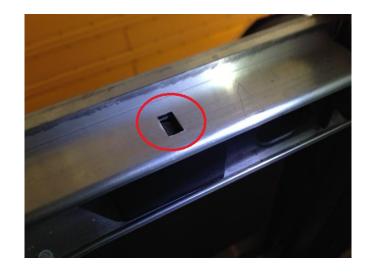
Once this happens the window drops – See Figure #4

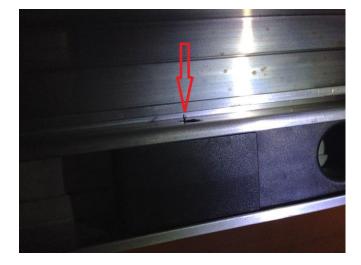
Then if the window is lifted back up past the stops the added force on the latches causes them to push out of their locking tabs which are in top of the upper rail – See Figure #5

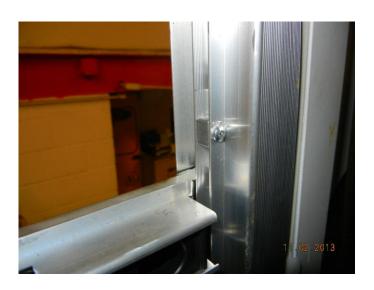
As this occurs or continues to occur, the aluminum channel where the lock is cut "slices" away at the latch tab and the latch is not able to properly seat in the tab - See Figure #6
