Microbird G5 Rear Destination Sign Bulbs

Body Tech Tip #13-0513

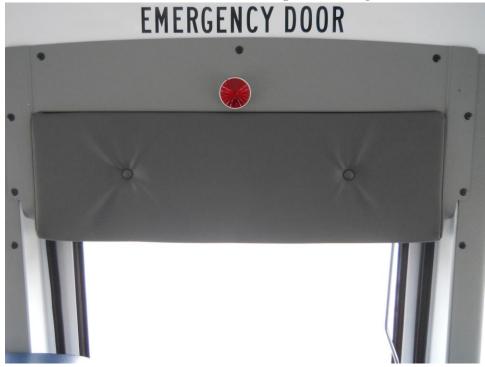
Locate the padded header over the rear entrance door

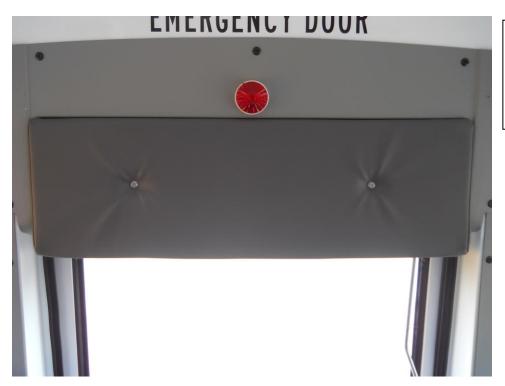
Locate the 2 "buttons" and remove them which will access 2 phillipshead screws – shown at left

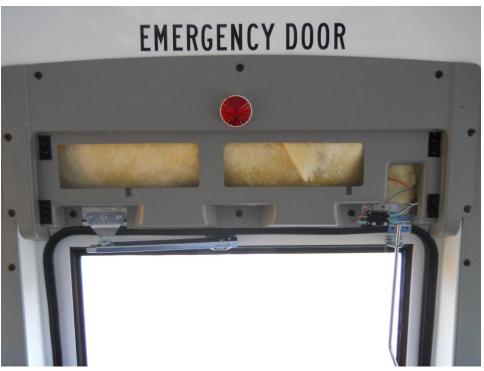
Once the screws are removed you will need to pull slightly at each corner as there are Velcro strips at each corner also – remove pad as shown at left

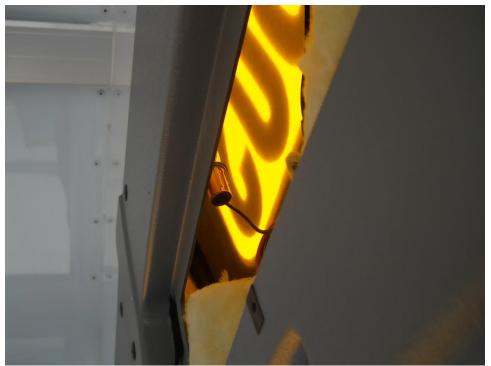
Once the pad is removed, bending down and looking to the inner side of the rear panel you can see the 4 light sockets

Reaching in through the 2 openings you can access the 4 sockets and change the bulbs

We recommend changing ALL 4 bulbs

Bulb #105
