## CEL/DEF Lights Illuminated or Flashes

### Service Update #22-0402

### DIAGNOSTIC CODE #3574 ACTIVE or INACTIVE

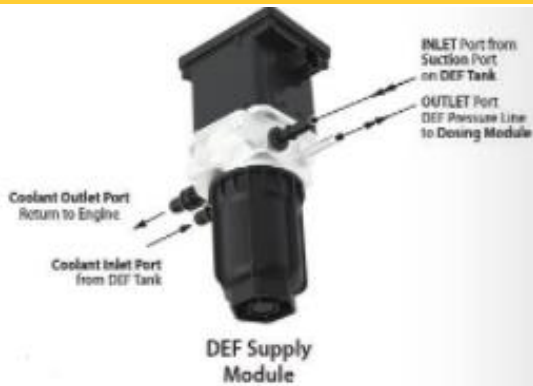
FIGURE #1

There are 2 Supply Modules used (FIGURES #1 & #2) and the one specific to units can be determined by the body number of the vehicle working with Parts seeing as the filter kits are different.

When replacing filters and servicing the system, you should completely flush and rinse the system with distilled water to remove any contaminants/crystallized DEF. In doing so, with the Supply Module shown in Figure #1, we found that there is a small screen located behind the inlet port shown below (FIGURE #8) and you may choose to remove the port to rinse or to replace the screen (FIGURE #9).

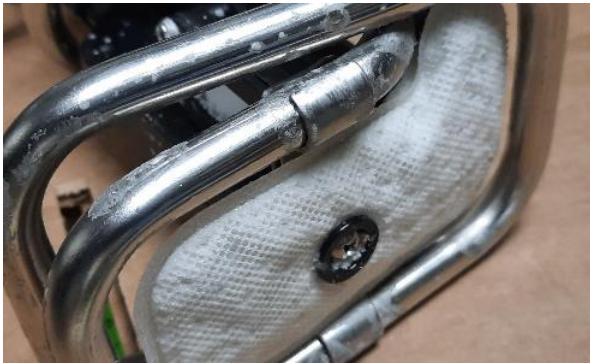
We proceeded to remove DEF heads and examine filters to find multiple issues. We found some where there was evidence of DEF “crystallizing as in FIGURE #3 around the mounting screw and the filter had crystallized DEF inside as can be seen where the filter appears “puffed” up. We found dirty and contaminated filters as in FIGURE #4 and we found evidence of dirty, crystallized DEF inside the filter which caused the filter material to contact the draw tube connector due to suction from a contaminated filter as in FIGURE #5.

We knew that to properly correct this condition that the system should be thoroughly cleaned and rinsed which could dislodge crystals and contaminants causing further issues. As stated in the description of the Supply Module, there is a serviceable 10 micron DEF filter in the which we feel should also be changed.

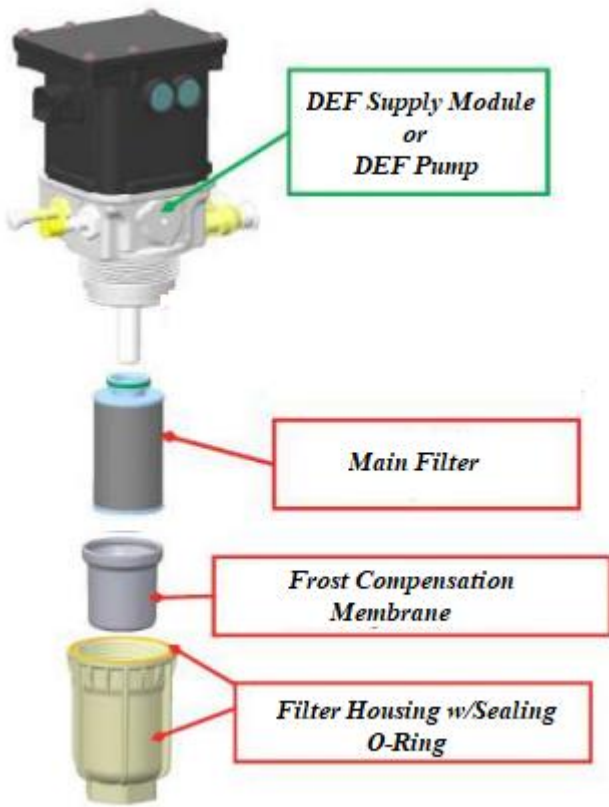
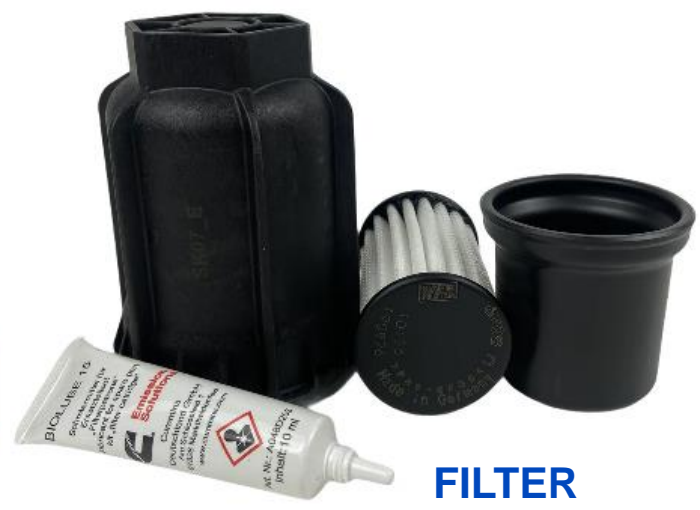
**FIGURE #6**

FIGURES #6 & #7 show the 2 different Supply Modules, the part numbers for the filter kits and their assembly.

PLEASE NOTE: The kit shown in FIGURE #6 comes with a new filter housing and lubricant where the kit in FIGURE #7 does not, but that kit does come with a tool to remove the filter.

**FILTER  
KIT #UF106**

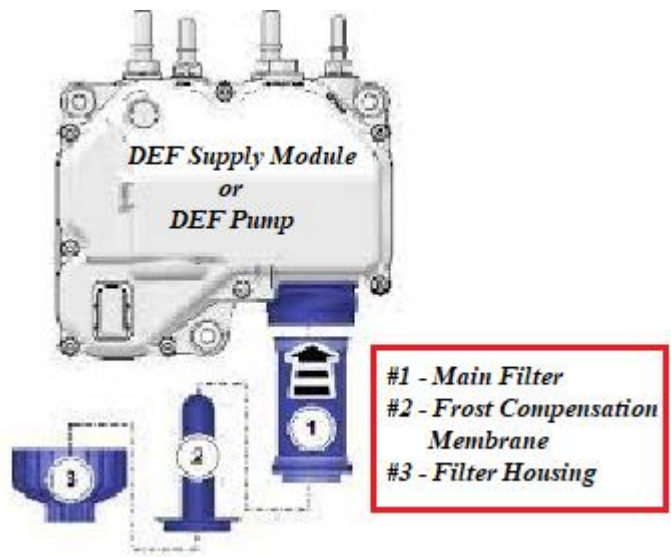
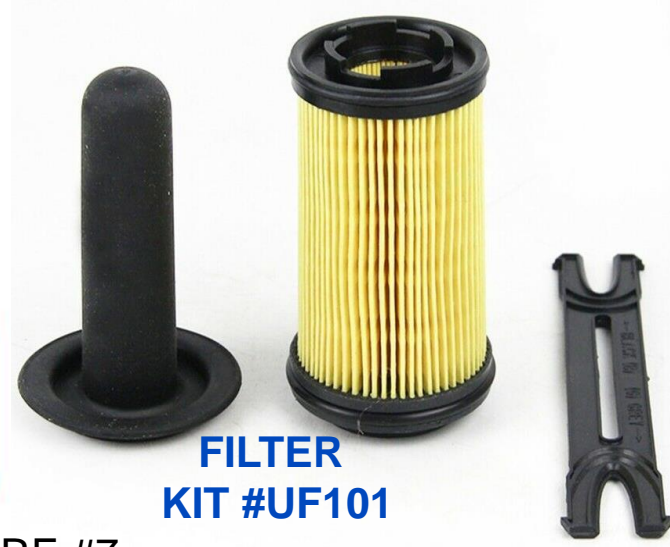
**FIGURE #7**

**FILTER  
KIT #UF101**

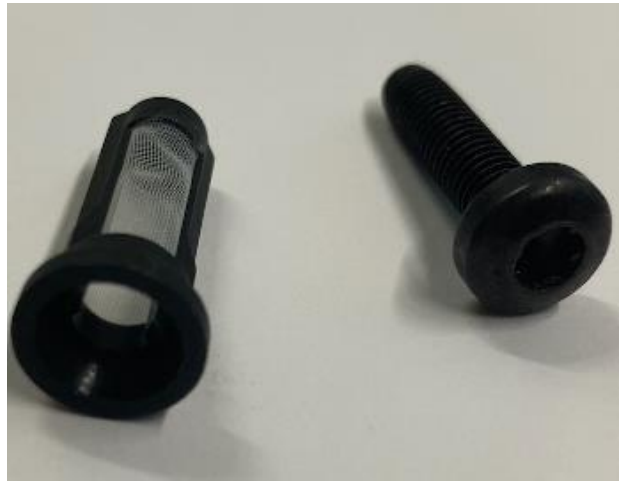
## SCREEN & REMOVAL TOOL #4388377 SHOWN IN FIGURE #9
