Stainless Steel Braided From Compressor to Air Dryer

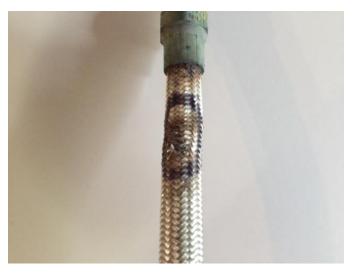
FIGURE #1 FIGURE #2

Complaint - We found that the stainless steel braided line from the compressor to the air

dryer had a spot where the braids are broken and the rubber hose is starting to

"bulge" through, please see Figures #1, #2 & #3.

Cause – We believe after reviewing several units that the cause maybe associated with the

plastic tag which is on the hose as identification Please See Figure #4. We suspect that road chemicals trapped beneath the tag along with the varying change in temperature as the units cycles air compressor cycles may be what is leading to

the issue.

Correction – Remove the tag from the line
