Tech Tip

Product Effected –All American “D3”

Complaint: *Driver’s are complaining of cold air in the driver’s area.*

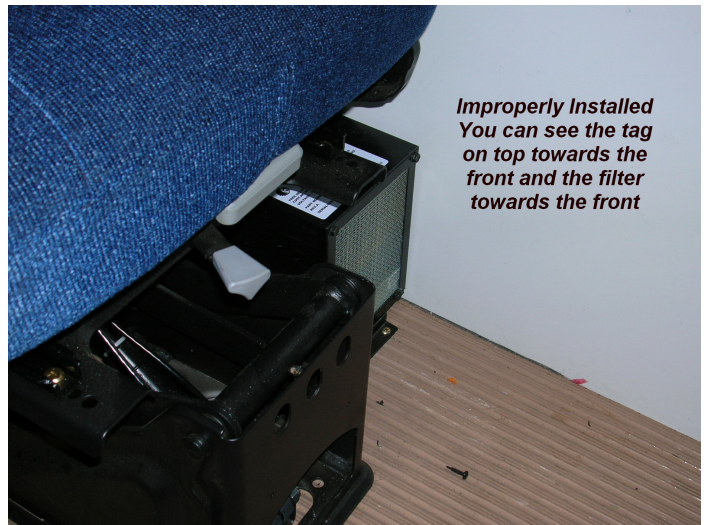
Figure #2

Correction: *To check, the easiest way is to turn the heater on and feel for air blowing forward. The other way is the shear positioning of the heater, as you can see in Figures #1 and #2 the heater sits back from the seat when not installed in the correct position and as in Figure #3 sits slightly forward of the base of the seat, you can also tell by the tag on top which should be to the rear as should the silver filter both shown in Figure #2*

*Improperly Installed
You can see the tag
on top towards the
front and the filter
towards the front*
