Product Affected-Units with Air Doors

Complaint - When the doors are closed, the manual door release set, then open the doors

Cause - There is full system pressure being allowed to be reintroduced to the air

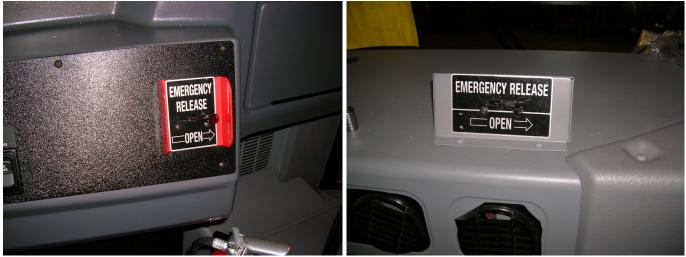
FIGURE #1 FIGURE #1A

#2 – Locate the air door release – Mounted in the panel just right of the driver on the BBCV (Fig.#1), Mounted on the top of the dash on the right center of the All American A3 (Fig. #1A), Mounted on the dash face of the All American D3 just to the right of the doghouse (Fig. #1B)

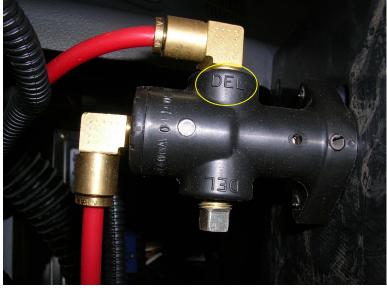
FIGURE #3

#2 – Remove the panel containing the door release so that you gain access to the air lines located at the back of the valve (Fig #3). Locate the brass 90* fitting located in the delivery port of the of the release valve. The port will be marked "DEL" (Fig. #4).

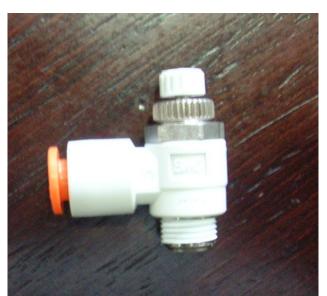
FIGURE #5

#3 – Locate "flow control" SEE NOTE (Fig.#5) and install where the brass fitting was, make sure the airline seats in the fitting and then insure all valves used to drain air have been closed and start vehicle building pressure fully at 120PSI. Shut vehicle down and listen for leaks at the valve, also watch the air gauge to ensure it does not drop......if you think you hear a leak check with soapy water to make sure.

This "Flow Control" valve was initially required and used with Air Door Cylinder #00125149 so you may find this already in the system - We will assure that ALL units being delivered with air doors from this point forward has this adjustment feature!

There could be 2 separate valves with either a 3/8" or 10 mm port – The following are correct part numbers –

- > 3/8" Part # 00128417
- > 10mm Part # 10004766
