# Tech Tip

From your friends at New York Bus Sales

## Product Effected – Units with Air Entrance Doors

**Complaint:** Air doors will not operate

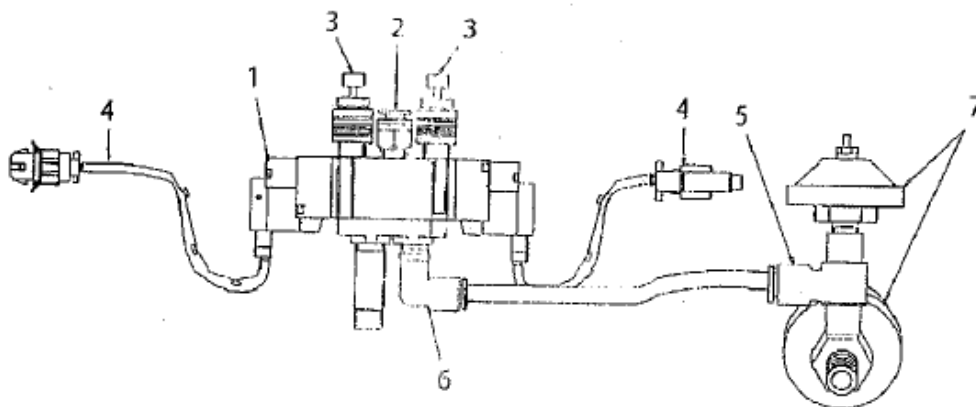
Cylinder Assy #00125149

is the first design and is suitable for the fact that the electrical plugs can be replaced if the wire ends break. Part number #10001178 is used and contains both plugs as one male and one female

**PLEASE NOTE: The first assembly #00125149 has been discontinued and replaced by the Current #10001867 and is a “plug and play”.**

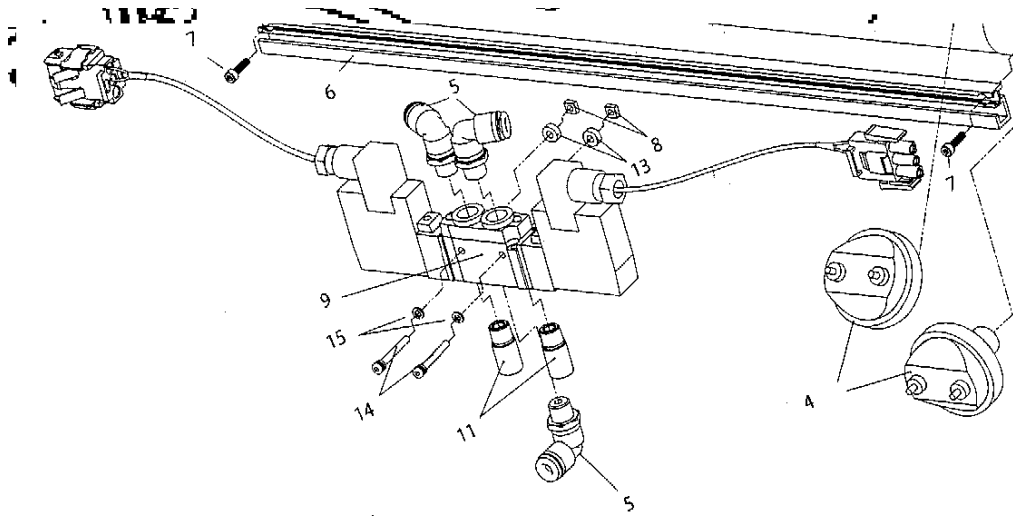
**Cylinder Assy #10001867**

This is the most current design and as you can see the plug ends are not replaceable. Should the wires break and not be repairable the valve assembly needs to be replaced which is part #10004776.

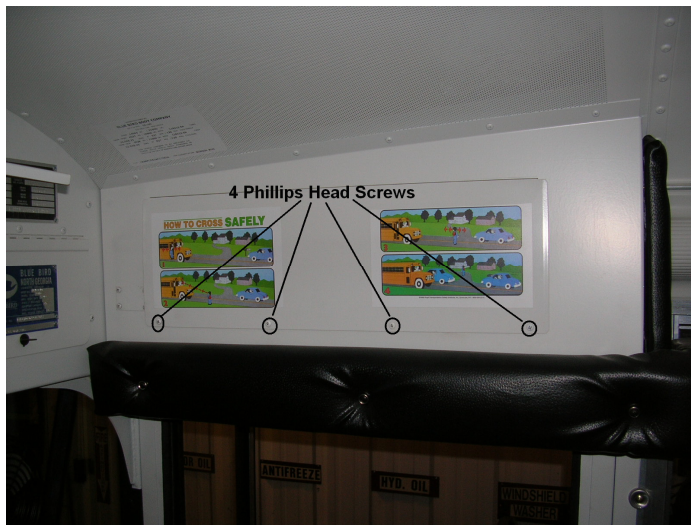
**Figure #1**

**Step #1 – Locate the panel above the entrance door and remove the 4 phillips head screws (Figure#1) to expose the air door cylinder. Once removed you’ll notice that the wires may be hanging and not properly secured (Figure #2)**

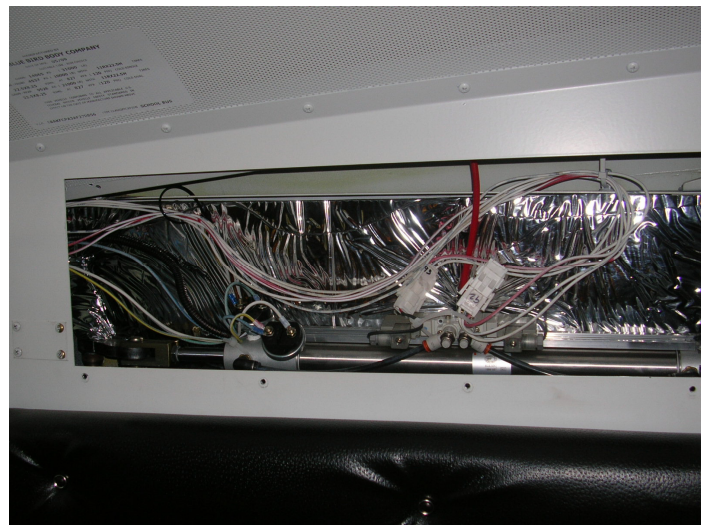
**Figure #2**

**Cause:** The wires to the air valve that operate the air doors are breaking right at the point where they go into the valve body or the wires connected to the switches are breaking due to fatigue from the movement of the cylinder. Even though the cylinder movement is minimal, the number of times it operates during the course of a normal day causes the wires to fatigue at their weakest point. Seeing as the gauge wire used for the valve is less they tend to break sooner and seeing as the switch wires see the most movement they also are prone to break.

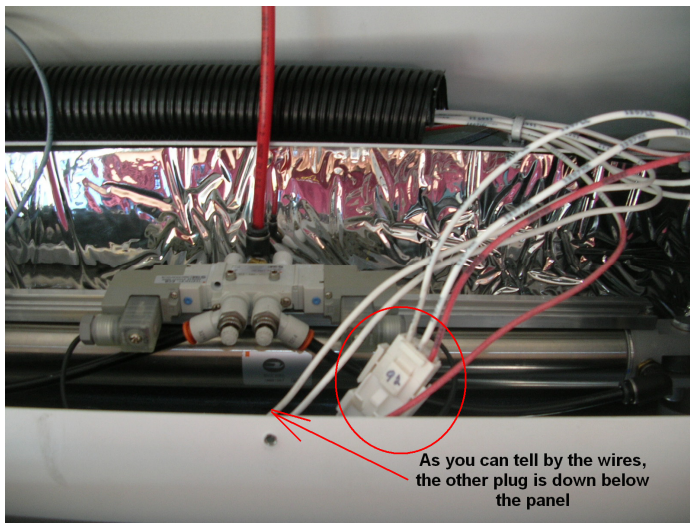
**Figure #3**

**Step #2 – Locate both white plugs ... Figure #3 shows the one plug and you can see by following the wires in the figure that the other plug is below the panel.**

As you can tell by the wires,  
the other plug is down below  
the panel

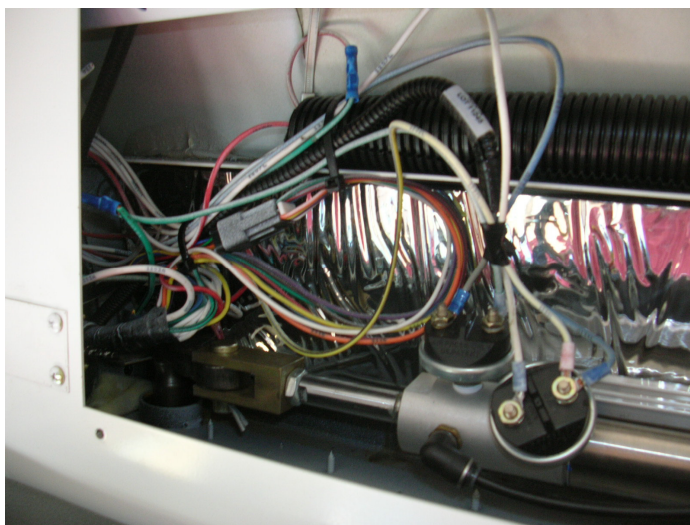
**Figure #5**

**Step #4 – Move to the front of the cylinder where the 2 switches (Part#01940873) are located (Figure #5). Separate the wires out leading to the switches and again tape them every 3” to 4” (Figure #6) Once gathered and taped together then leave some slack to the terminals on the switches and secure the end of that harness .... We use the forward switch (Figure #7)**
