## Micro Bird Entrance Door Adjustment Procedure

### Tech Tip #24-0308

### Adjustment May Be Needed After Unit Is In Service

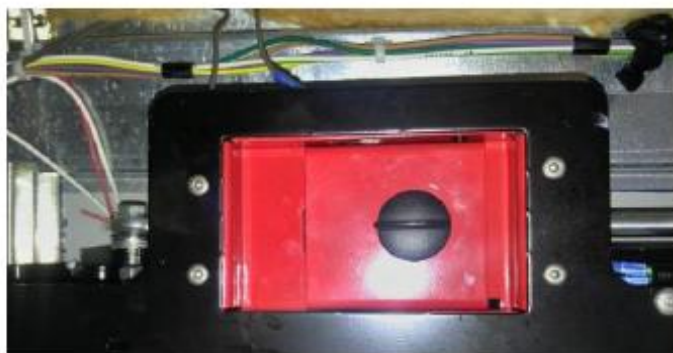
**Warning:** If the vehicle is equipped with an outside service door emergency handle (Option EDER) make sure that the lock (Option I70) is deactivated (see picture below for reference) before adjusting the service door.

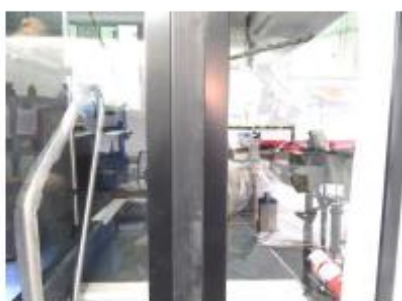
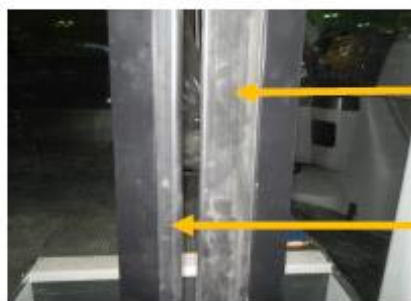
**Step 1:** While standing outside the bus, make sure the service door rubber seals are installed correctly as shown on these pictures.

Large rubber seal on right (front) door leaf. Flat side out.

Small rubber on the left (rear) door leaf.

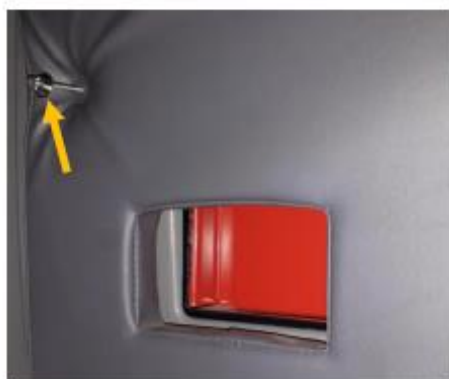
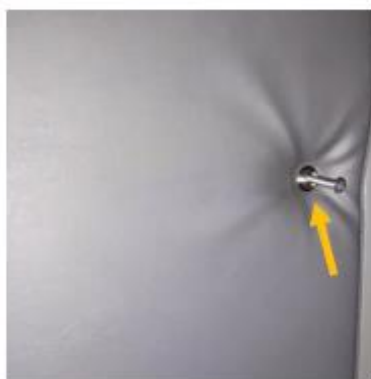
**Step 2:** Carefully remove the head pad above the service door. Make sure to safely keep the removed cover caps and screws since you will need them to reinstall the head pad.

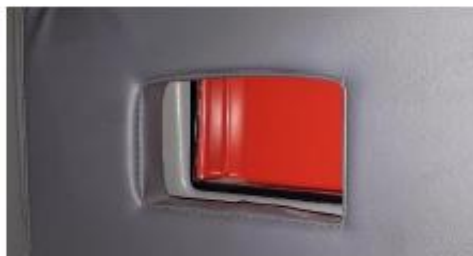
1. Release tension on the threaded rods by pulling the emergency release located above the service door.

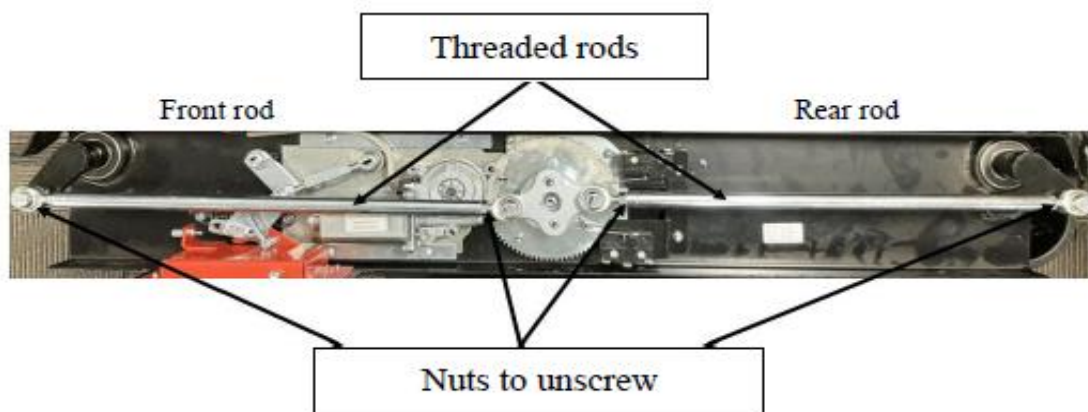
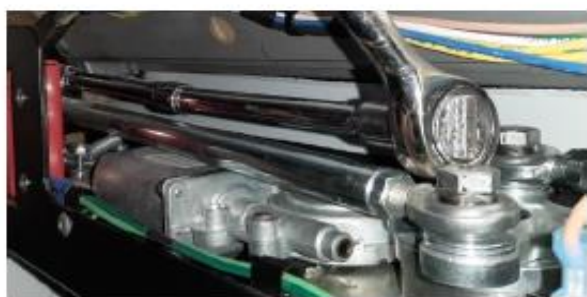
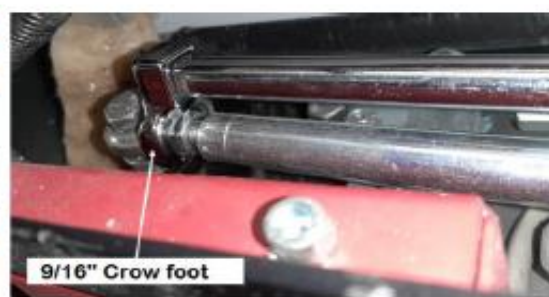
2. Unscrew the four (4) nuts at the ends of the rods. You could use the crowfoot wrench extension.

3. Give the front treaded rod eight (8) full turns clockwise (toward you) and four (4) to the rear one. The door should normally open a little more.
4. Engage the service door emergency release, and then open and close the service door using the console switch. At this point, it is normal the door remains slightly opened.

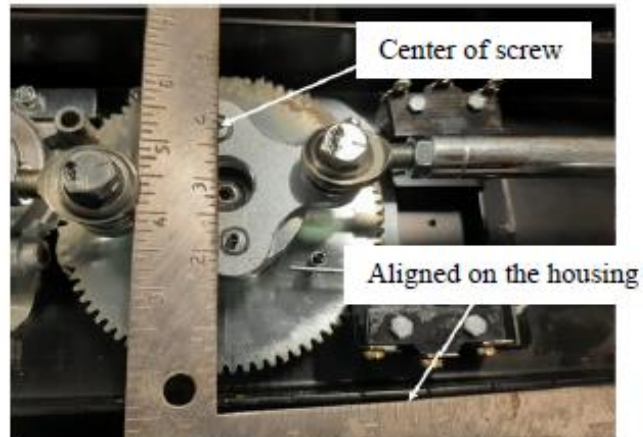
5. Press one side of the square along the inside of the cabinet. Align the other end with the center of the top pivot screw (located nearest the outside wall of the bus) as shown below.

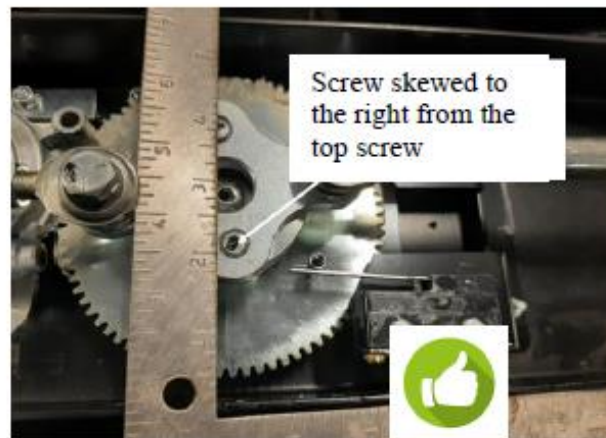
6. If the pivot is oriented correctly, the bottom screw is slightly skewed to the right as shown below.

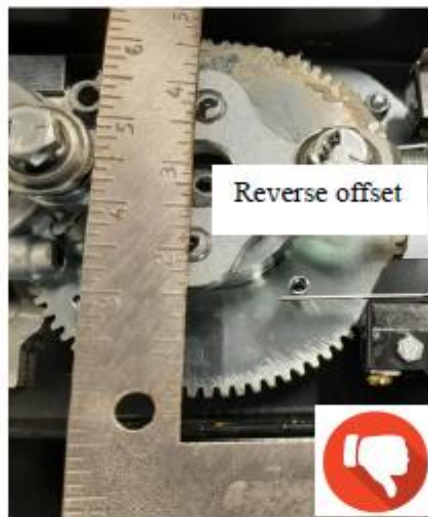
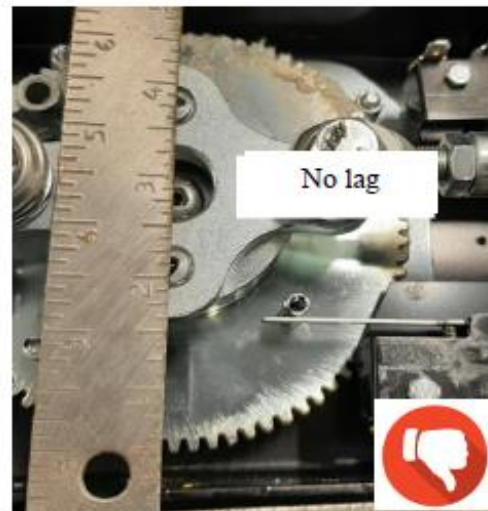
The following figures illustrate situations where the pivot is not oriented properly.

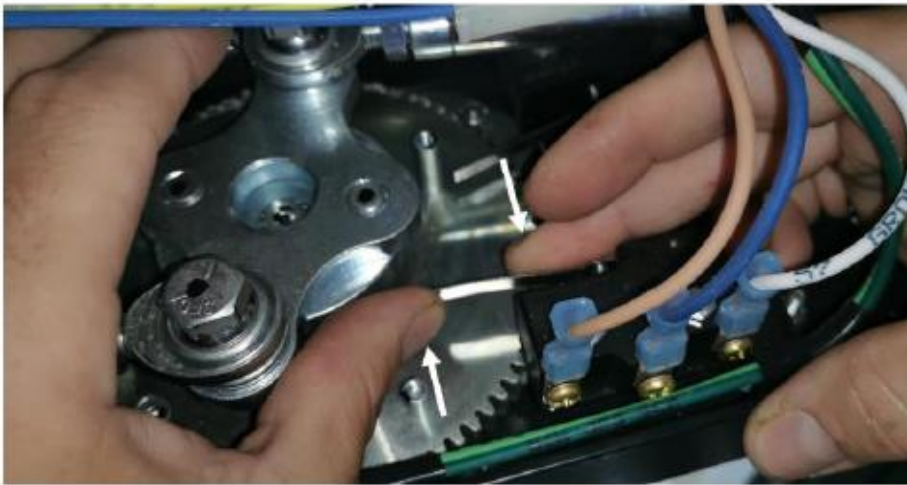
1. Make sure that the door panels do not touch the doorstep. If the door is still pressing the frame, give some more clockwise turns (toward you) on both rods. Verify and repeat in case there is still contact between a door panel and the steps.
2. Open and close the door using the console switch. Verify the orientation of pivot as per Step 3.
3. If the pivot is not oriented correctly, hold the tab and bend its end slightly away from you as shown below.

4. Open and close the door using the console switch. Verify the orientation of the pivot. If the orientation is correct, proceed to the door adjustment. Otherwise, repeat Point 3 until the pivot is oriented correctly.

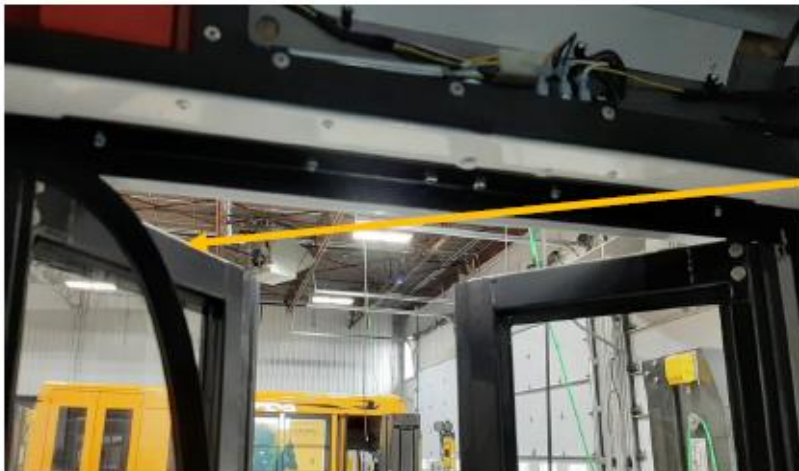
1. With the door opened, pull out one end of the upper seal to completely free the center of the top doorframe, as shown on next picture. Be careful, the upper seal is fixed with sealant at both ends.

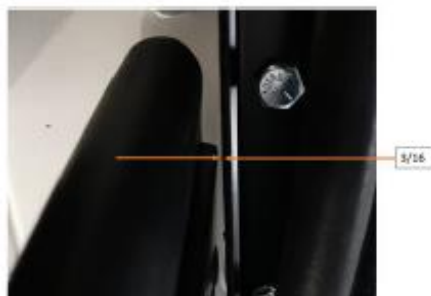
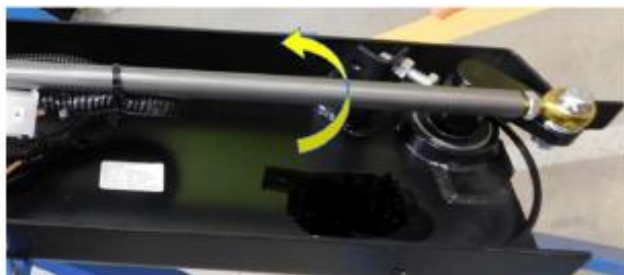
3. With the door closed, start adjusting the rear door panel by turning the rear rod outward (away from you) until the top of the panel is  $\frac{3}{16}$  inches from the top frame. You could use a  $\frac{3}{16}$ in shim to help or measure regularly using a ruler. It might help to use vise grip pliers to turn the rod.

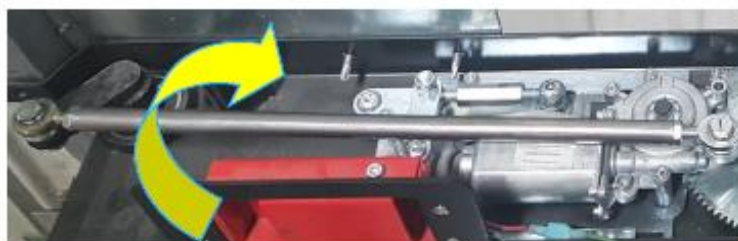
4. Open the door using the console switch and reinstall the upper seal.
5. Close the door using the console switch.
6. Proceed with the front rod, using pliers to rotate. Turn it outward (away from you) until the top of the front panel rubber seal touches firmly the rubber seal of the rear panel until there is no visible gap between the two panels rubber seals.

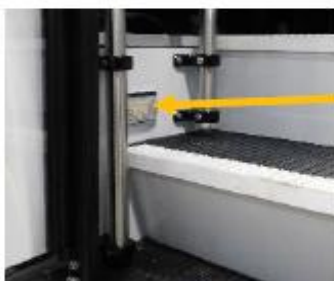
Stepwell light

7. Open and close the door to validate that the panels do not touch or block each other when closing. If they touch each other, open the door half-course to loosen tension on the rods and turn the front door panel rod outward a quarter of a turn. Repeat until the door panels do not touch or get stuck while closing.
8. When the door is completely shut, the stepwell light should turn off. If it is not the case, repeat from beginning of Step 5.

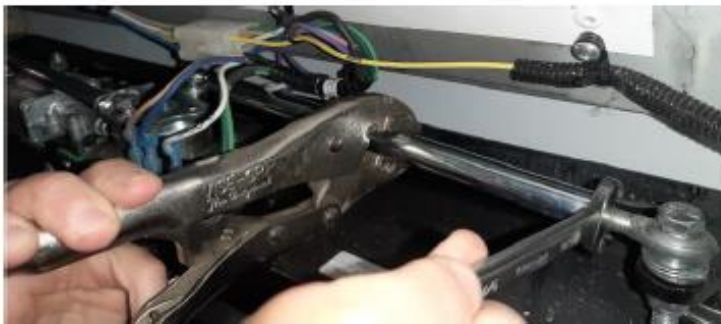
1. Make sure the service door emergency release is in the closed position and close the doors with the console switch.
2. Tighten the four (4) lock nuts at the ends of the rods, retaining the rod with the pliers so they do not turn. Once the lock nut is in contact with the rods, give an additional 1/4 turn.
