Battery Box Access with 3 Group 31 Batteries on a Vision Service Update #24-0217

Cable Routing Can Impede Battery Access W/3 Group 31 Batteries

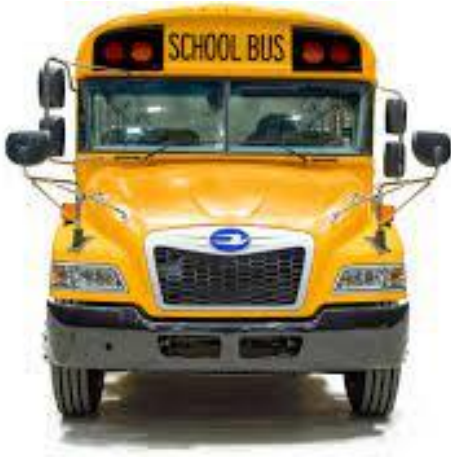
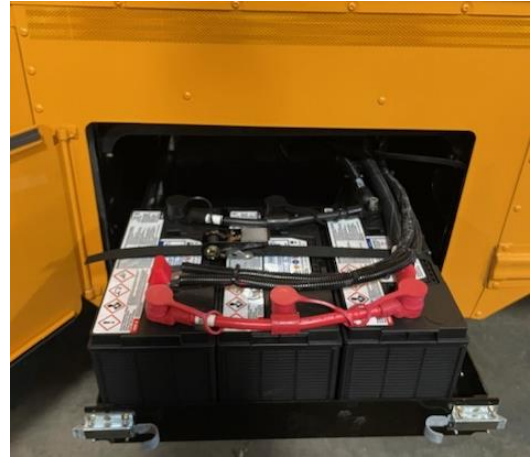
Upon investigating the issue, we have found that the issue is more too due with the battery cables and how they are mounted and routed than an issue with the tray slides which are often thought to be the culprit.

Figure #1 shows where a cable has dropped down behind the tray which does not allow the tray to fully slide into position for the latches to easily catch as designed.

To address this issue, pull the tray out to where the batteries can be serviced or replaced and then secure the zip ties of the saddle clamp.

Once you have done that, ensure that when you slide the tray back in that the cables loop onto the tray to the side of the bracket (towards rear of the unit) and not behind the tray.

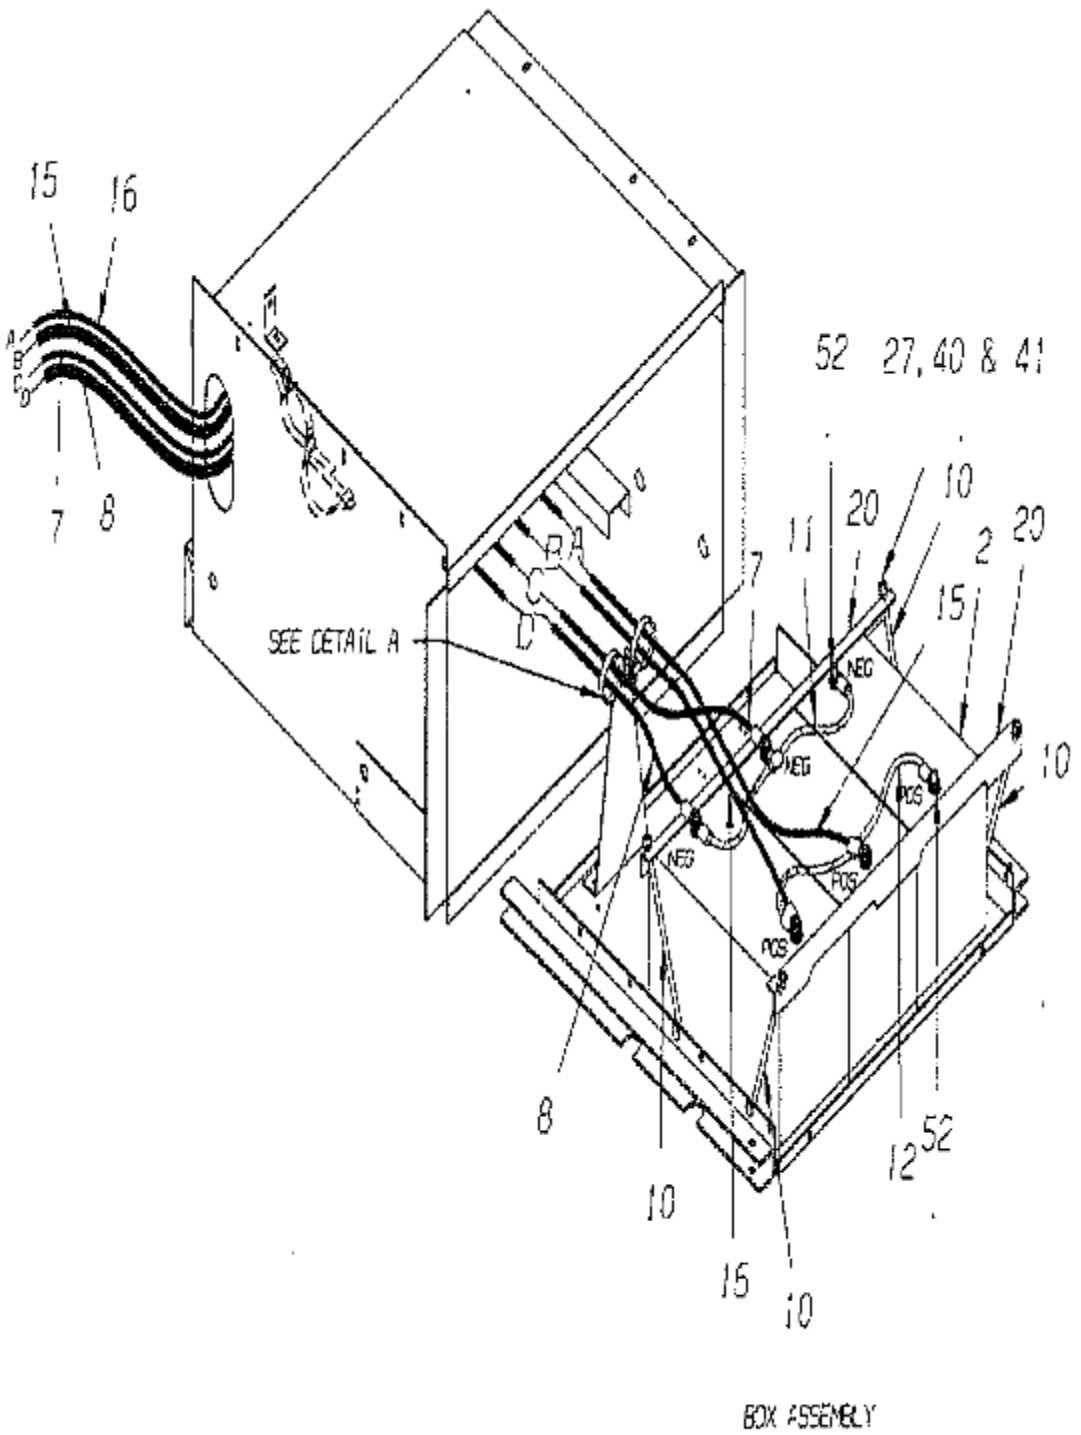
FIGURE #2

Referencing the diagram of the battery box, tray and cable routing in FIGURE #2, we see that there is a bracket mounted to the rear of tray listed as “DETAIL A” and shown in FIGURE #3 .

USING 3 DELCO BATTERIES

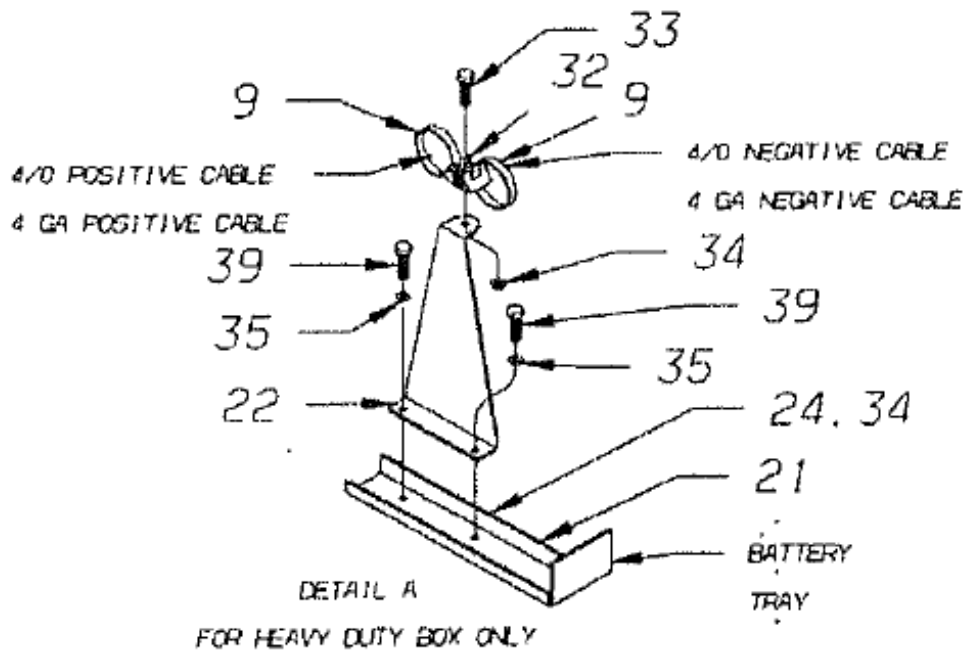
FIGURE #3

As you can see, there is a 2 way “Saddle Mount” zip tie (#32) mounted to the top of the bracket which guides and holds the battery cables.

What has been found is that the zip ties are not securely holding the cables and they are allowing the cable to slip behind the tray, or they are not secured at a location where the cables fall into the side of the bracket and onto the battery tray.

Should you find the “2 Way Saddle Mount” needs to be replaced
 You can order part #00030876
