Power Steering Reservoir “O”-Ring Service Update

If Not Checked, P/S O-Ring May Get To Pump And Cause Damage

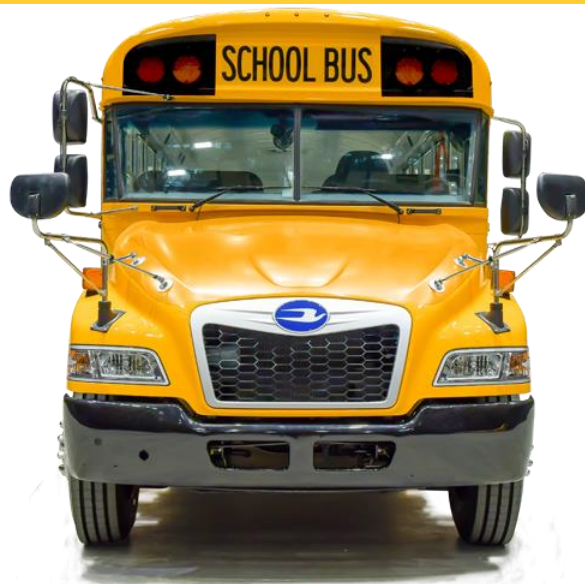
Recently we have seen where the power steering pump starts to make noise. When diagnosed, it is determined the pump needs to be replaced.

We are not sure how the "O"-Ring came off or got into the reservoir but seeing as replacing the P/S filter is part of normal maintenance, your techs should be made aware that there is an "O"-Ring in the cover and that should it fall into the reservoir while servicing the filter, extensive damage could occur to the P/S pump.

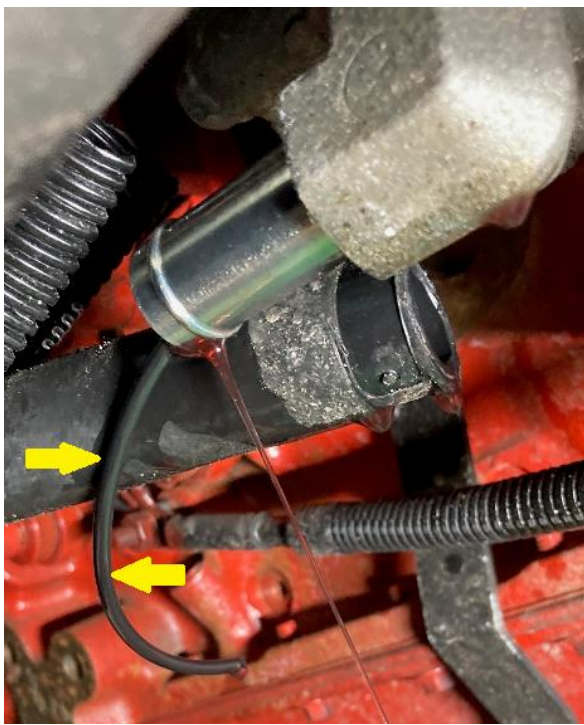
While replacing the pump the first step generally is to remove the lines and drain the fluid, which when done with the suction line revealed a long slender piece of rubber which was lodged in the veins of the pump. (FIGURE#1)

FIGURE #1 shows the line when the hose was removed, and FIGURES #2 & #3 show the piece stuck in the veins.

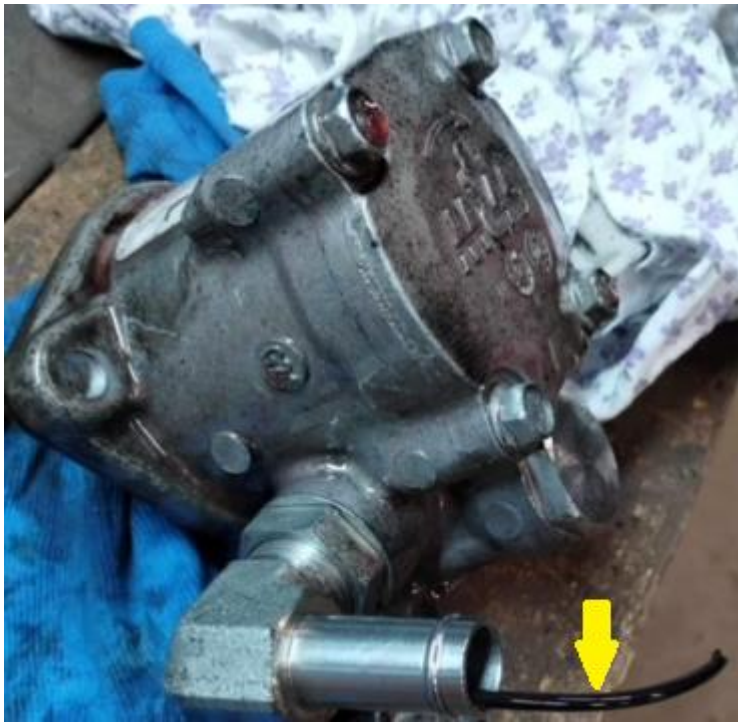
FIGURE #2

Initially it was thought that the piece might have come from inside the hose, but further investigation show it was smooth and appeared to be an “O”-Ring

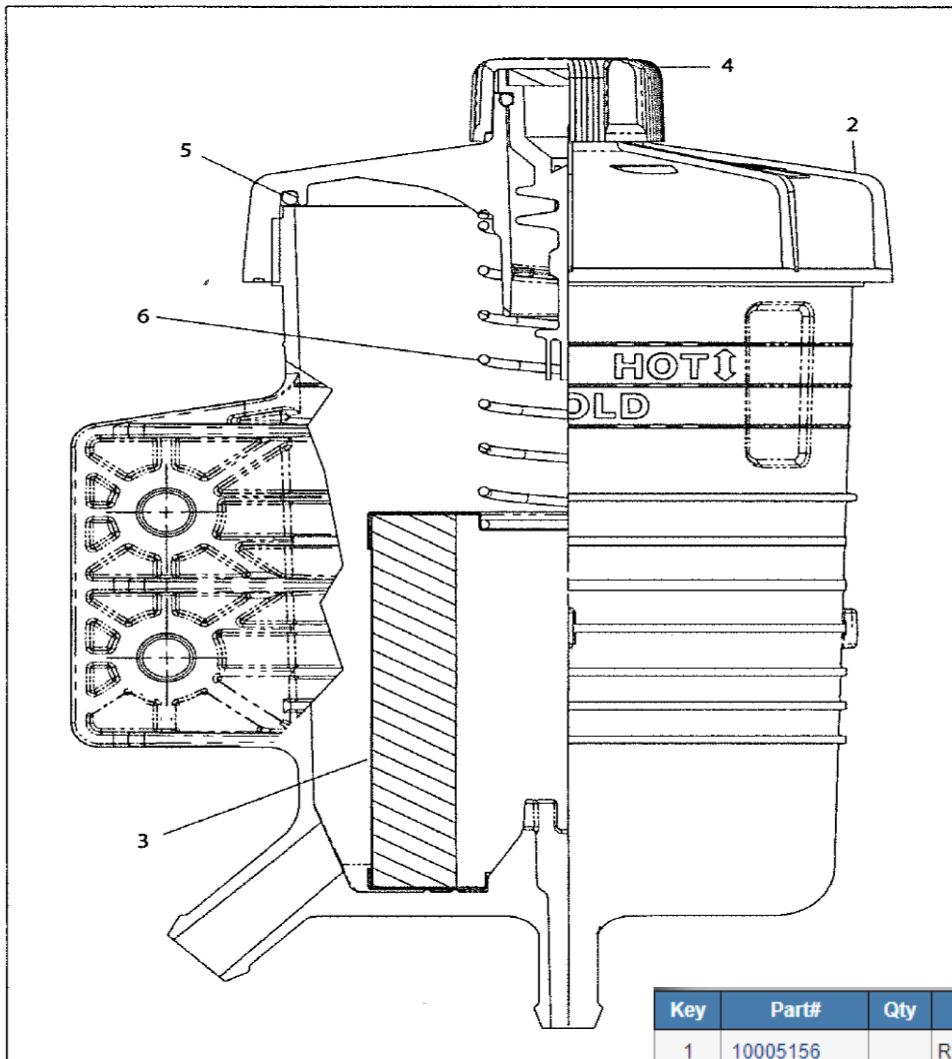
FIGURE #3

Once it was determined to be part of an “O”-Ring we needed to see where it came from. Going back to where the line originates at the reservoir we knew that it must be part of the reservoir, but where? Removing the cover revealed that “O”-Ring for the cover (Key #5/Figure #4) was missing and had fallen into the reservoir at some point and been sucked into the pump.

Key	Part#	Qty	Description
1	10005156		RESERVOIR,POWER STEERING,1.5 QT,
2	10012413		COVER,STEERING,RESERVOIR
3	10005525		FILTER,ELEMENT,PSR,510 MEDIA,870807A
4	10012412		DIPSTICK,STEERING,RESERVOIR
5	10012411		O RING,GASKET,STEERING RESERVOIR
6	10012410		SPRING,STEERING,RESERVOIR
