Hendrickson AIRTEK & SOFTEK Front Suspension

Service Update #24-1215

Preventative Maintenance Tips

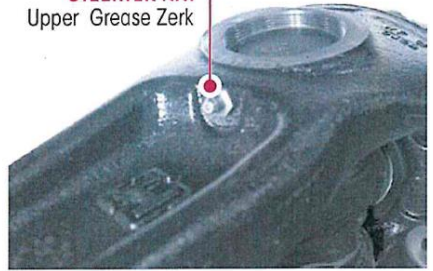
FIGURE 7-1

STEERTEK NXT upper kingpin grease zerks are located on the inboard side of the steering knuckle and upper kingpin connection, see Figure 7-1. Models of the STEERTEK NXT a grease Zerk is located on the bottom of lower steering knuckle.

STEERTEK NXT
Upper Grease Zerk
