Hood Alignment and Adjustment Service Update #25-0522

Don't Assume the Hood is Properly Aligned.....Check It!

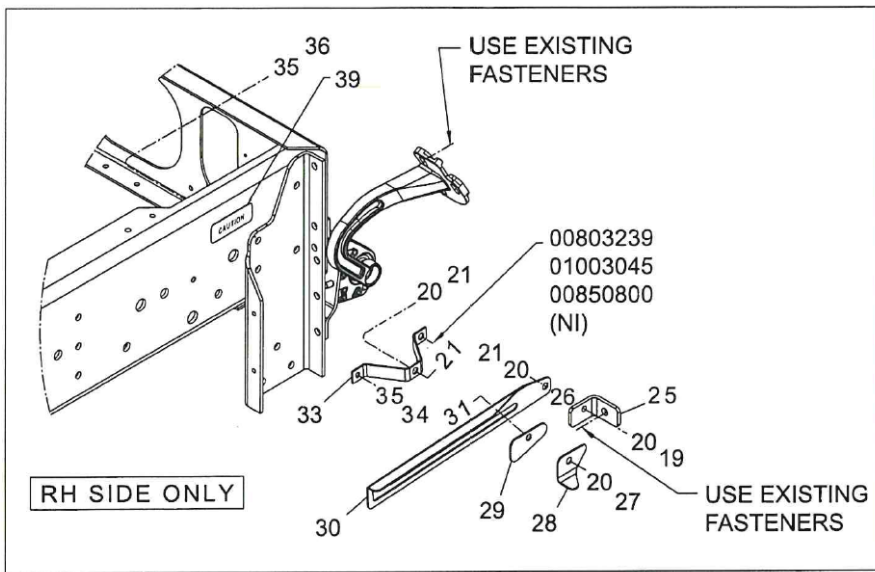
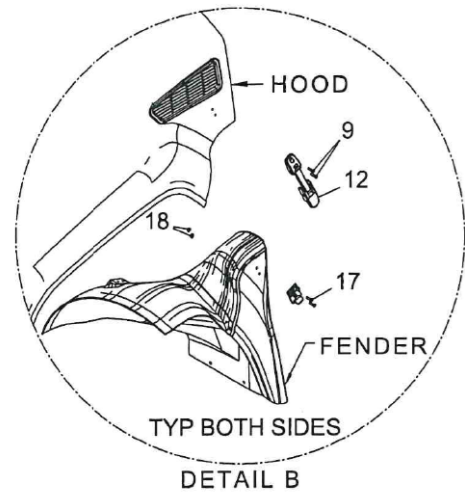
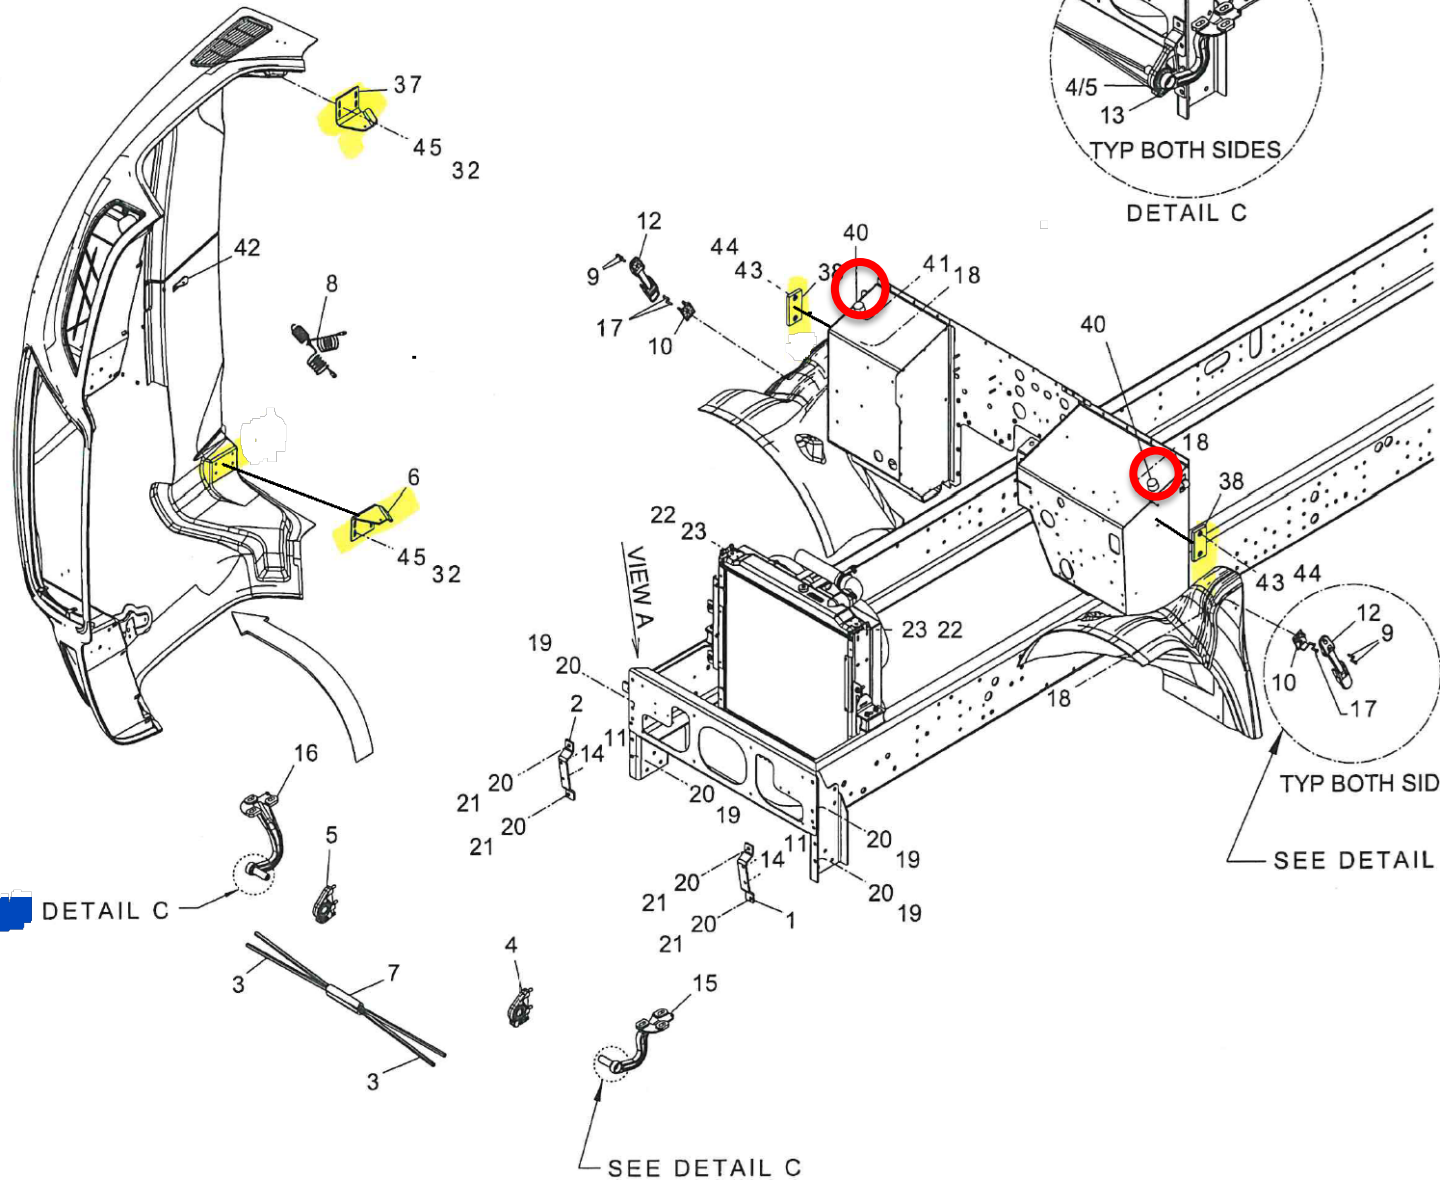
FIGURE #!

First, we need to understand the parts involved in the hood adjustment. In the attached schematic of the hood (FIGURE #1), you have the following:

- #38 – Part #00088228 (2) which are the neoprene spacer plate mounted to the outer sides of the toe boxes. **Hi-lighted yellow.**
- #40 – Part#00102929 (2) which are the rubber isolators on the top of the toe boxes toward the outer edge. Circled in **RED.**
- #6 – Part #10053481 (1) which is the right hand “Guide Bracket” for the hood. **Hi-lighted yellow.**
- #37 – Part#10053482 (1) which is the left hand “Guide Bracket” for the hood. **Hi-lighted yellow.**

The basis of this is for when the hood is closed that it is resting on the rubber isolators on the toe boxes and when “latched” is held tight. We have all seen the flexibility in the hood when just opening and closing and the amount of “twist” that the hood has. Therefore, what also needs to happen is that the side-to-side movement needs to be minimized which is addressed by having the hood “guided” into place and centered on the rubber isolators by adjusting the Left Hand and Right Hand “Guide Brackets” so that when closed, the hood “slips” into place.

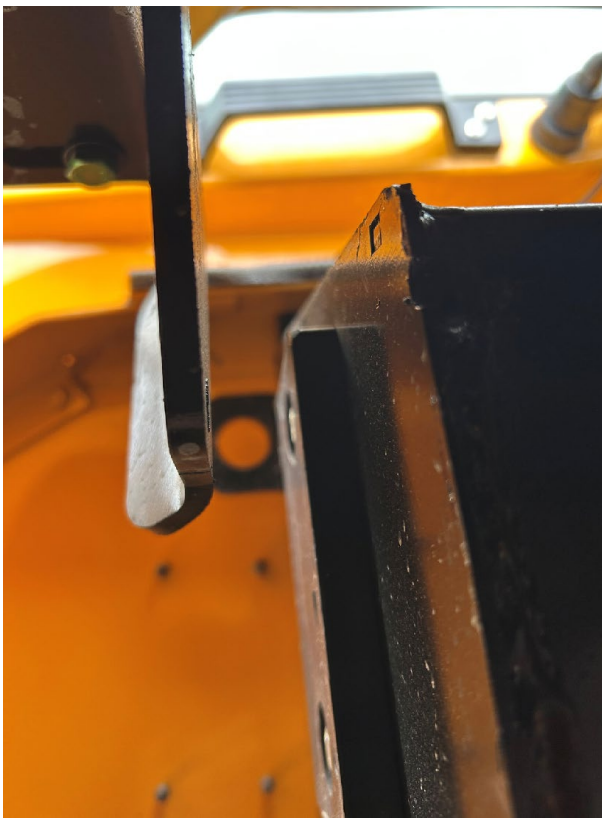
There are basically two adjustments to the hood, and they are adjustments in the distance between the right and left “Guide Brackets” to spacer plate. FIGURE #2 shows a large gap between the “Guide Bracket” and the spacer plate, this should be about 1/8” and to adjust, the Guide Bracket mounting holes are elongated to allow adjustment. (FIGURE #3).

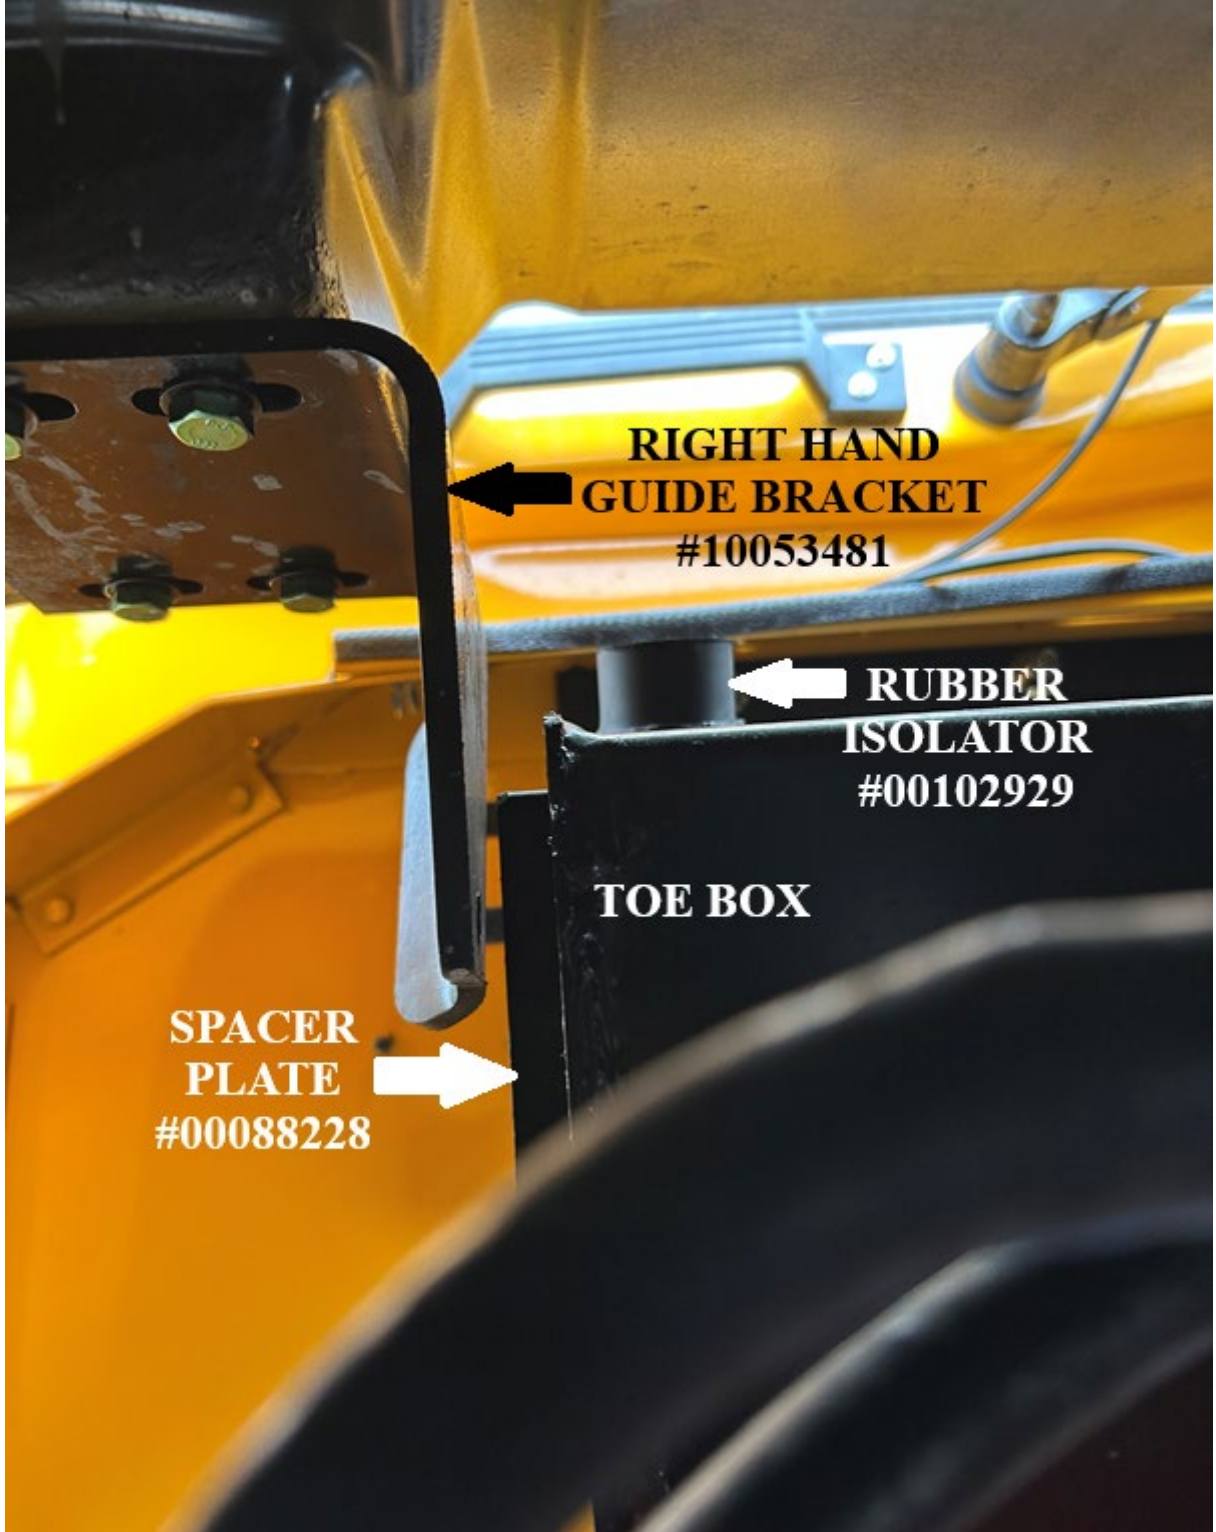
FIGURE #4

Positioning the bolts for the bracket in the center of the elongated holes will get you a good starting position where then only minimal movement will be required to get the 1/8” clearance (FIGURE #4) to keep everything in alignment and tight which will allow the hood to open and close easier and lessen vibrations in the hood while traveling over bumpy roads!
