# IMMI Seat Belt Retractor Issue

## Service Update #26-0723

### 3-Point Seat Belt Retractor Not Working

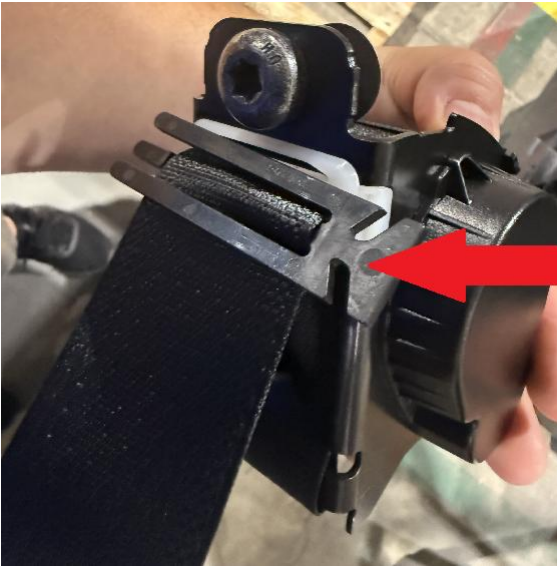
FIGURE #1

After further diagnosis, we found that the retractor was fine, and the issue was that the “clip” installed on the retractor when the seat was assembled was not removed and was not allowing the belt to retract. FIGURES #1, #2 & #3 show the clip installed on the retractor.

Removing the clip will allow the retractor to work as intended.
