Vision Front Fender Extension “Flare”

Service Update #20-0122

Front Fender Extensions Are “FLARING OUT” At The Bottom

Service Instruction “SI-65-300-901 Vision Front Fender Trim”

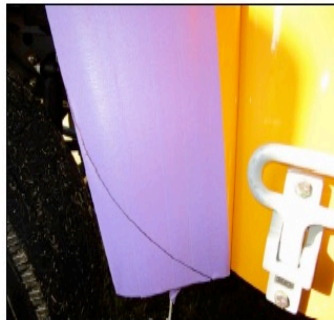
Photo 3

It has been found that the front fender extensions on earlier model Vision units over time will tend to “flare” out at the bottom just behind the front tire. This has been addressed in production with the implementation of a fender extension that has a slight radius.

1. Cut Template from Second page of instruction to complete repair.
2. Place Template on outside of left-hand fender extension. (Photo 1). Apply masking tape to fender extension where the trace line from template will be made. (Photo 2)
3. Use Marker to Trace the cut line of the template onto the fender extension. (Photo 3)
4. Using Coping Saw cut along the trace line. (Photo 3)
5. Remove tape left on fender.
6. Use a fine-tooth flat file to smooth out any rough edges. (Photo 4)
7. Use Template in reverse to trim right-side fender.
 - Note: Use reference measurements on Template to confirm that it has been printed to the correct size.
