Tech Tip

Product Effected – 2006 Thru 2008 BBCV (Vision)

Hendrickson Tie Rod Ends

S07MC
SERVICE BULLETIN

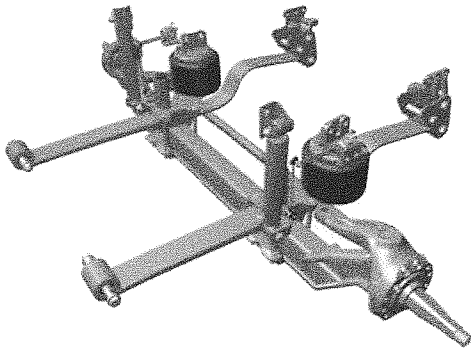
Third generation tie rod ends were used on Blue Bird Visions from July, 2006 to present date. This tie rod end can be identified by a flat area on the top of the casting very near the rubber bushing. The Blue Bird replacement part numbers for this style tie rod end are 0118432 (Left) and 0118433 (Right).

The tie rod ends for the Second and Third Generations are interchangeable even though visually they are different shapes and are from different manufacturers.

WARNING Always install the correct Hendrickson parts and follow Hendrickson instructions for replacing the tie rod ends and/or tie rod assembly.
