Tech Tip

FROM YOUR FRIENDS AT
NEW YORK BUS SALES!

Blue Bird BBCV (Vision)/GM 8.1L Propane Engine w/single serpentine belt

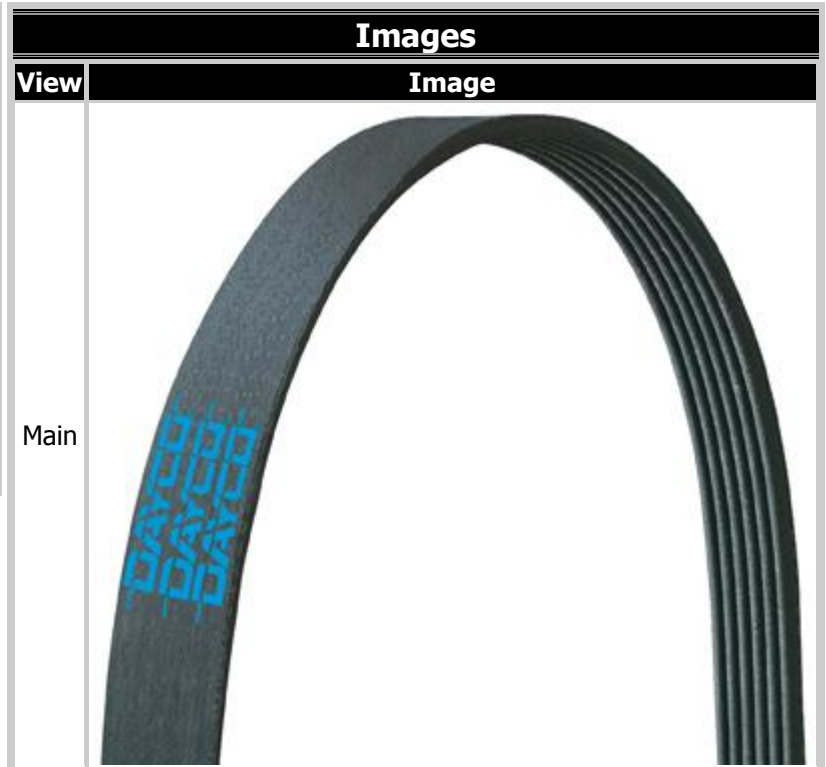
PLEASE NOTE – WE FOUND THAT THERE IS A DIFFERENCE IN BELT MANUFACTURES ALSO AS SHOWN BELOW THE DAYCO SPEC ON THE LENGTH IS 136.02” WHERE THE NAPA BELT WHO IS MADE BY GATES IS 136.5” WHICH COULD EFFECTIVELY CAUSE AN ISSUE WITH THE BELT TENSIONER POSITIONING –THEREFORE IT IS STRESSED THAT OEM PARTS SHOULD BE REPLACED WITH OEM PARTS

Part#: 5061360

Part Specifications	
Attributes	Specifications
Backside Material	Rubber
Compound	EPDM, Aramid Reinforced
Effective Length (in)	136.02
Metric Part	6PK3455
No of Ribs	6
Rib Depth	Standard
Rib Profile	Straight Rib
Thickness	.169
Top Width	.82
