Vision Gas/LPG with Code #P0504

Service Update #23-1223

Unit has CEL with code #P0504

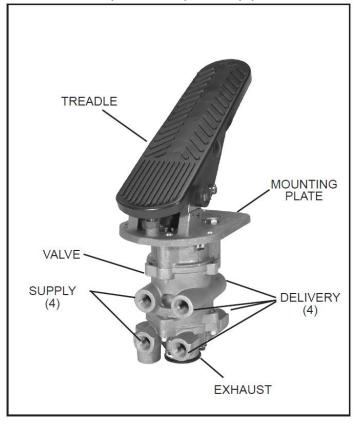
Once the locknut (#16) was removed from the threaded end of the stem and spring seat nut (#25), spring seat (#26), rubber spring (#27) and primary piston (#27) were removed, it was evident the rubber spring had worn unevenly on the shaft of the primary piston and telltale evidence is found with debris from the worn spring seat and rubber spring are shown in the "cup" of the primary piston.
