Microbird T-Series Driver's Door Tech Tip #17-0311

MICROBIRD T-Series Driver's Door Alignment

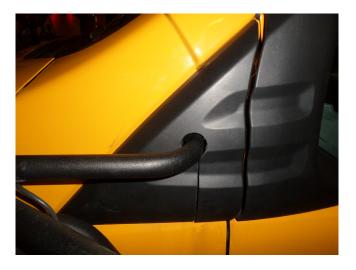
Figure #1

- #1 At the bottom of the "A" pillar there is a black plastic trim piece which covers the upper mirror mount. (Figure #1). Gently pry this off as it is held on with clips. Once removed you will notice that the upper mirror mount is bolted to the unit using the hinge bolts (Figure #2).
