Driveline Guard – Missing Brace on A3FE and BBCV Units

Service Notice #18-1109

Missing Brace May Cause Driveline to Contact Air Brake Components on A3FE and BBCV Units

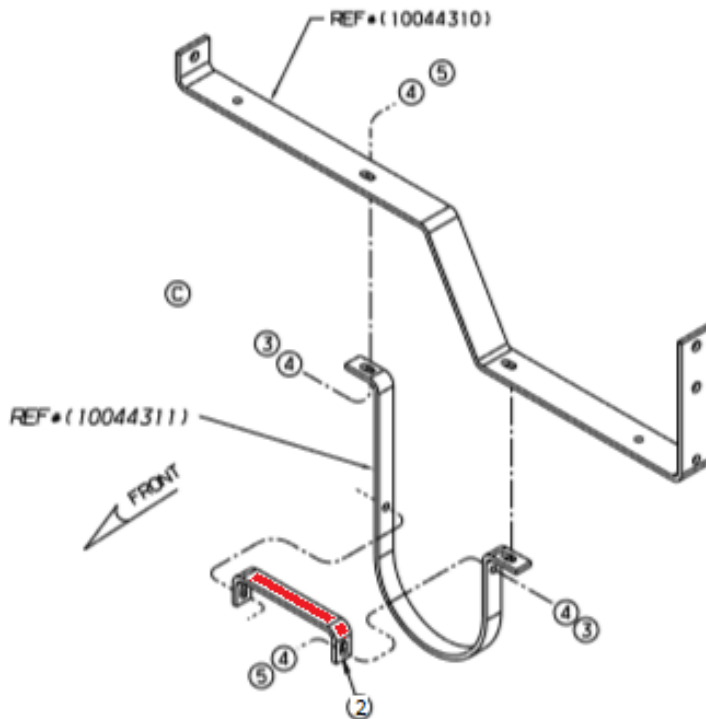
The guard in question is shown in Figure #1 and is a “mid-mount” guard which is generally mounted to protect the center section of the driveline near the air tanks as in Figures #2 & #3.

TORQUE ITEM #5 29-33 FT-LBS.

Generally we have found that most units have the holes predrilled in the “loop” for the cross-brace and installing is a matter of bolting the brace (shown in red in Figure #1) and torquing the bolts to 29-33 ft/lbs.

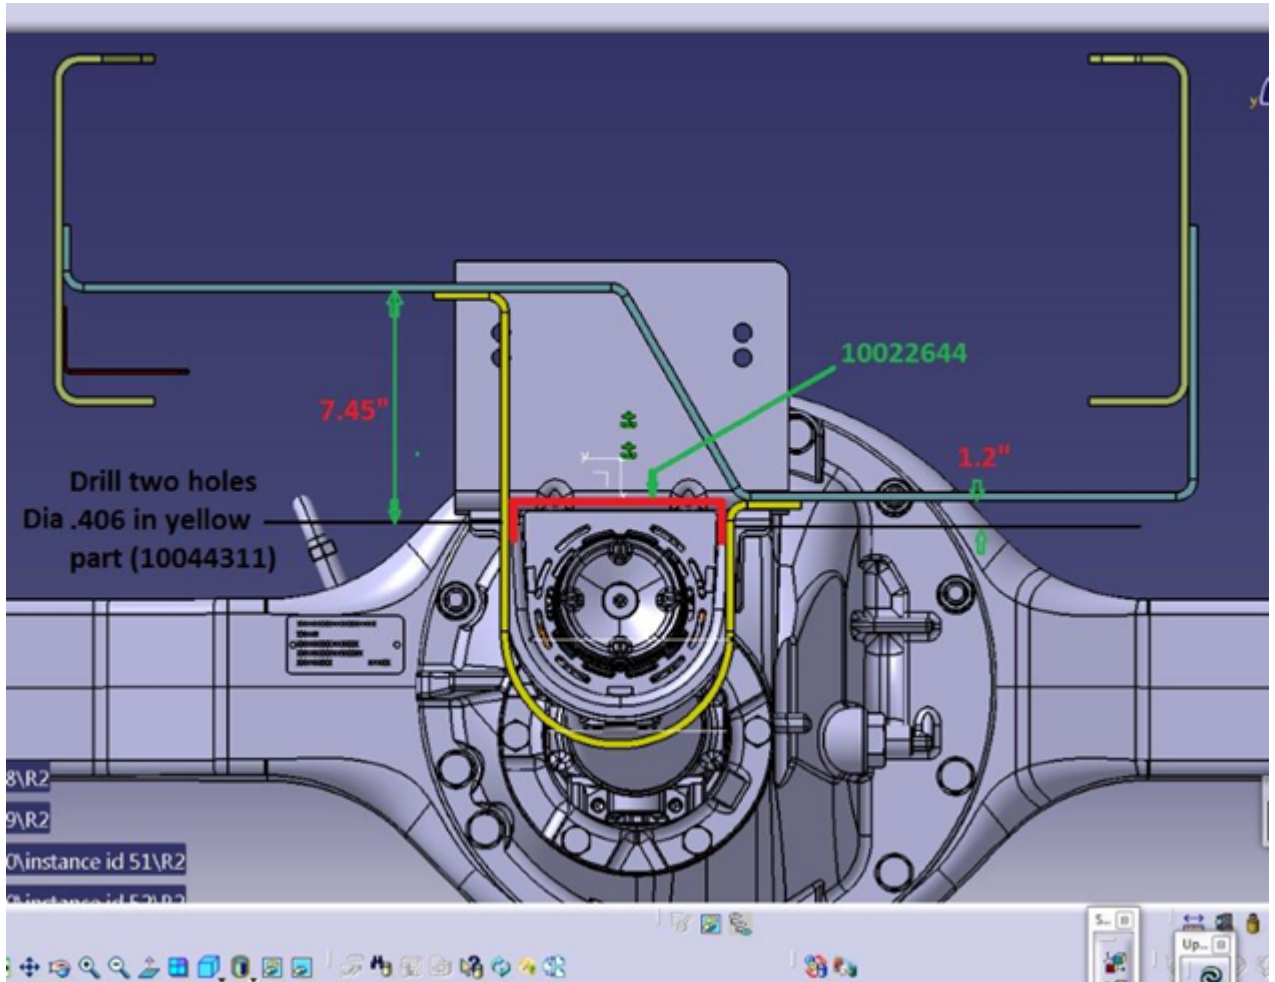
There is an added photo showing the brace placement in Figure #4 should holes need to be drilled.

BRACE PART #10022644
