16-0201-3

## AA/BBCV Seat Mounting @ Wall W/Simultaneous Load Seats

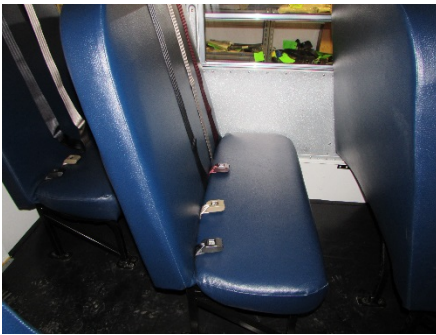
Figure one

On the 39" – "3" child seat (high back w/lap belts) there are 3 bolts which mount the seat to the "ledge" of the wall – Please see Figures 1-2-3.....Figure 3 shows the 3 bolts through the seat ledge holding the seat to the ledge.

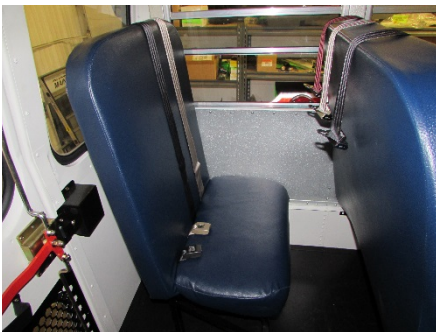
Figure 4

The seat(s) in question are the 26" and 30" "2" child seat (high back w/lap belts) generally found in the left rear of a unit. Please see Figures 4-5-6. Figure 6 shows the two bolts through the seat ledge holding the seat to the ledge.

Blue Bird has verified this is correct and confirmed that 26" and 30" seats meet the required "pull" test with two bolts as the weight requirements are less than the 30" seats. Blue Bird drawing #D0019630 (FIGURE #7) and #D0019637 (FIGURE #8) are highlighted to show the bolt requirements for the 26" and 30" seats respectfully.
