# Tech Tip

## Blue Bird BBCV (Vision)/GM 8.1L Propane Engine w/single serpentine belt

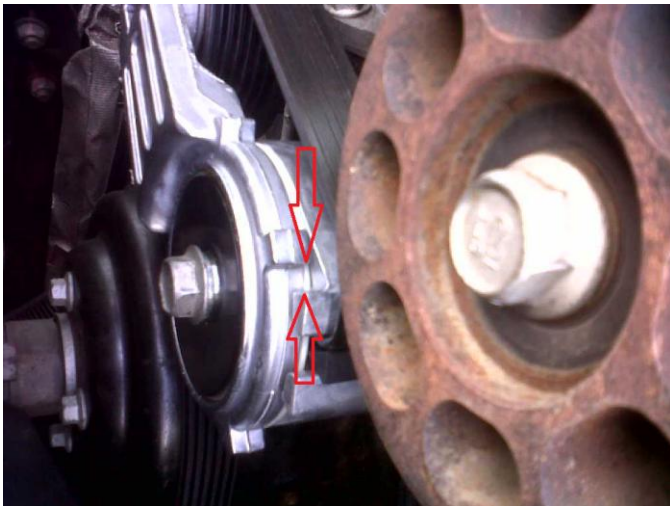
- Complaint –** The belt tensioner nubs are running too close showing that the tensioner +/- or belt are worn. A slight “chirp” may be heard on shutdown of the engine – Please see Figure #1 & 2.
- Cause –** If the belt or the tensioner has recently been replaced it may be the improper part, if not the belt +/- or tensioner may be worn.
- Correction –** If the belt +/- or tensioner have recently been replaced and the “nubs” of the tensioner are still close you need to make sure that the proper parts have been used. See the text box below-

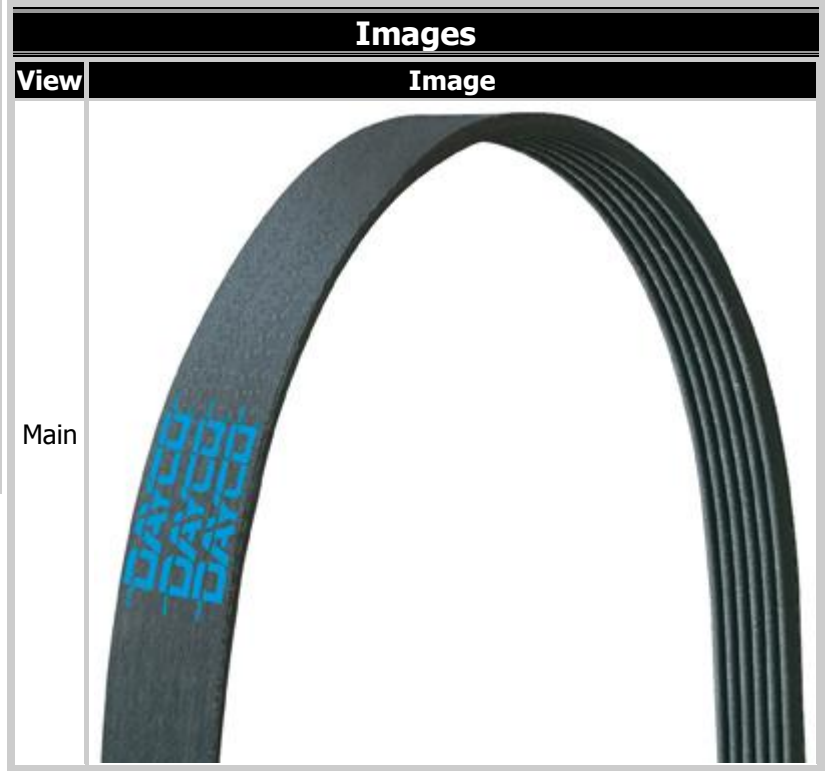
**PLEASE NOTE – WE FOUND THAT THERE IS A DIFFERENCE IN BELT MANUFACTURES ALSO AS SHOWN BELOW THE DAYCO SPEC ON THE LENGTH IS 136.02” WHERE THE NAPA BELT WHO IS MADE BY GATES IS 136.5” WHICH COULD EFFECTIVELY CAUSE AN ISSUE WITH THE BELT TENSIONER POSITIONING –THEREFORE IT IS STRESSED THAT OEM PARTS SHOULD BE REPLACED WITH OEM PARTS**

Part Specifications	
Attributes	Specifications
Backside Material	Rubber
Compound	EPDM, Aramid Reinforced
Effective Length (in)	136.02
Metric Part	6PK3455
No of Ribs	6
Rib Depth	Standard
Rib Profile	Straight Rib
Thickness	.169
Top Width	.82

Part Number: NBH 25061360  
Product Line: NAPA Belts & Hoses

# Serpentine Belt Ribs : 6  
Outside Circumference (in) : 136.5"  
Outside Circumference (mm) : 3467 mm  
Section: K Top Width (in) : .807"  
Top Width (mm) : 20 mm

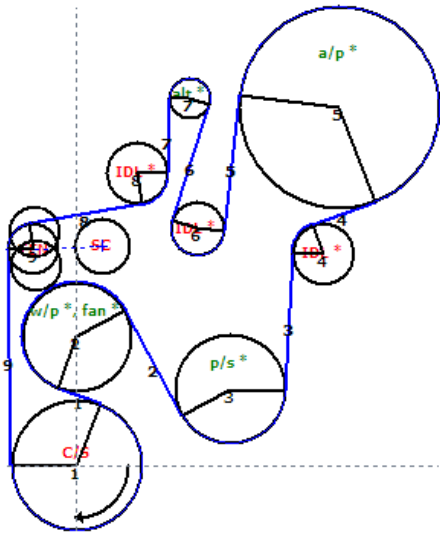
**PLEASE NOTE –** Figure #4 also gives the proper belt routing-
