Service Update – Ford Battery Management System

Service Update #21-0402

E-Series May Exhibit Similar Characteristics

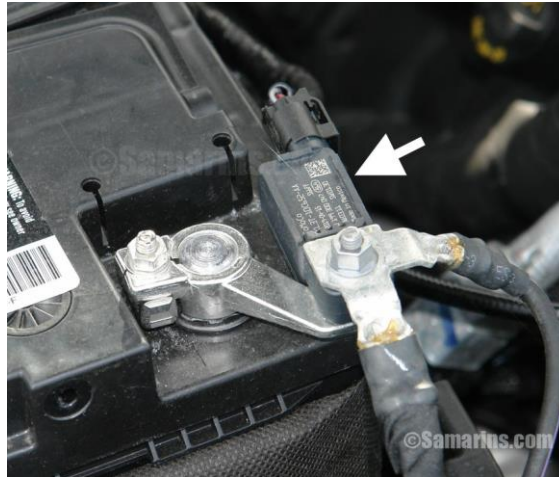
PLEASE NOTE: Presence of the BMS can be determined by a sensor attached to the negative terminal of the battery as shown in the photo above.

There is a “RESET” procedure for this system and on this particular unit we were asked to perform the reset even though the unit in theory would not have the system. Upon performing the reset, the unit’s lights then properly operated. After research by Micro Bird, it was determined that the “Vehicle Control Unit” may present similar behavior in certain circumstances and conclusion was made that the reset procedure can be performed on an E-Series unit even without the presence of the BMS system.

The following procedure resets the value for the BMS:

1. Close all doors, windows and hood
2. Turn key in ignition to ON (not accessory)
3. Set the exterior light switch to A for automatic or only parking lights
4. Within 10 seconds, activate the high beam lights pulling the arm towards you 5 to 7 times
5. Then press and release the brake pedal 3 times
6. Wait for the battery indicator in dash to flash

It is recommended to leave the vehicle without using it for 8 hours after procedure for BMS to finish recalibration.
