ANGELTRAX CAMERA SYSTEM DOWNLOAD ISSUE

Electric Tech Tip #13-1002

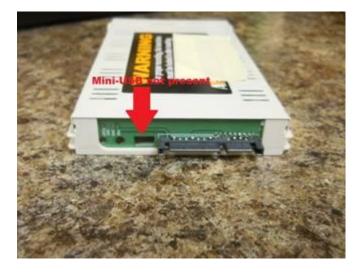
Figure #1 Figure #2

Complaint - In trying to retrieve video from our AngelTrax system, we tried to hook into the

"mini"-USB (Shown in Figure#1) but it's not there anymore!

Cause – New for this year, to increase security in data transmission, AngelTrax has

changed the method of retrieving data to include a piece of hardware called a

"SECKEY1"

Correction - Contact your local New York Bus Sales Parts Department and order a

"SECKEY1" and it will be shipped at No Charge –

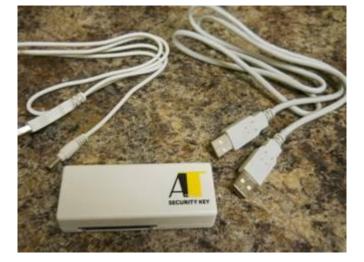
Once you receive the SECKEY1, you will notice it comes with 2 wire leads (Figure #2). The actual "key" or white box will slide onto the hard drive and then the 2 cables should attach to your computer (Please note that they are both USB cable ends so your computer will need to have 2 USB ports, one will be used for data transfer and the other for power). You can now use your computer as you have in the past.

PLEASE NOTE – The SECKEY1 can be used on older hard drives, but you will not be able to use the MINI-USB cable you used on previous hard drives with this years' units!
