Tech Tip

Blue Bird Type C & D w/Air Ride – Exhaust Shield

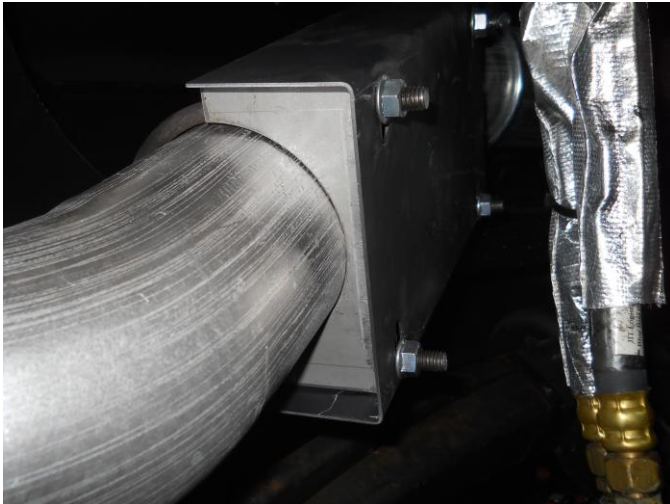
Figure #1

- Complaint –** There is an air leak at the back of the unit
- Cause –** New York Bus Sales as an added protection to the rear air brake lines added an exhaust shield (Figure #1). The bracket will over time cut into the air brake hose causing a leak.
- Correction –** Remove the shield – The foil wrap installed by Blue Bird is more than sufficient protection for the hoses.
