## "Weep" hole in GM Propane Muffler from AutoJet

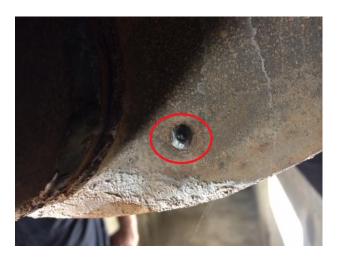
FIGURE #1 FIGURE #2

Complaint – There is what appears to be a "welded" weep hole in the front "cover" of the muffler – Please see photos #1 & #2

Cause – During production, the weep hole was mis-drilled in this location. To address this they welded the holes and re-drilled the holes on the case towards the bottom (Figure #3)

**Correction –** No Correction Needed

PLEASE NOTE – With the weather conditions being as cold as they have been over the past couple of weeks, you may note what appears to be an excessive amount of water coming from the weep hole. This is normal in cold weather as there is much more condensation!
