Blue Bird T3FE Electrical Stud

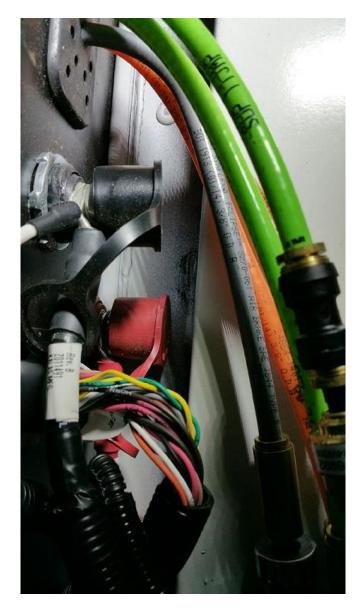
FIGURE #1

Cause – In the group of air lines running through the firewall by the driver's feet, one has a hole in it (Figure #1). Upon further inspection the black and red covers for the power studs were found to have come off and the nut holding the electrical connectors were not tight which caused

heat and the airline had laid against it causing the hole.

Correction – You should be checking to make sure that the protective caps are in place. As a preventative measure you should ensure the lines do not run close to the studs and that nuts are tight.
